## An Adaptive Reuse and Restoration of a Maine Barn

A Thesis Submitted in Partial Fulfillment  
of the Requirements for a Degree with Honors  
(Civil Engineering)

This is a study of a post and beam barn in Orono, Maine that examines the changes necessary to use the barn as an event center. Included is a structural analysis of the current barn structure to determine its adequacy for the new use under current design standards, including IBC 2009. The architectural portion of this study examines the capacity of the building and the egress and restroom facilities requirements for that capacity, as well as the ADA requirements. Provided is a final design that incorporates the architectural aspects and the structural changes necessary to meet modern standards. Structural modifications to the roof and floor framing and an addition for restrooms and kitchen space are recommended.

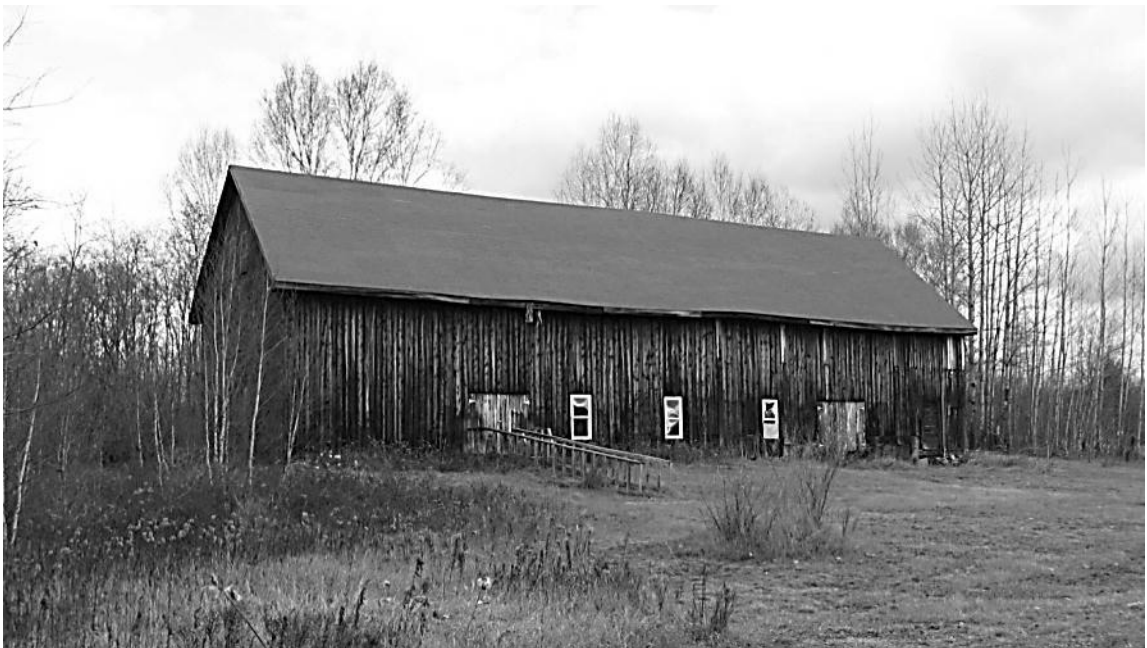
**Figure 2: Exterior View of Existing Barn**

Dr. Markowsky is interested in using the barn as a small event center: a place to hold meetings, weddings, wedding receptions, concerts, dinners, lectures, and other special events (Millennium Barn, 2002). Dr. Markowsky would like to preserve the acoustics and interior aesthetic of the barn. He is also interested in whether or not the barn can be used year-round (Personal communication, GM, 2011). See Figure 2: Exterior View of Existing Barn below.

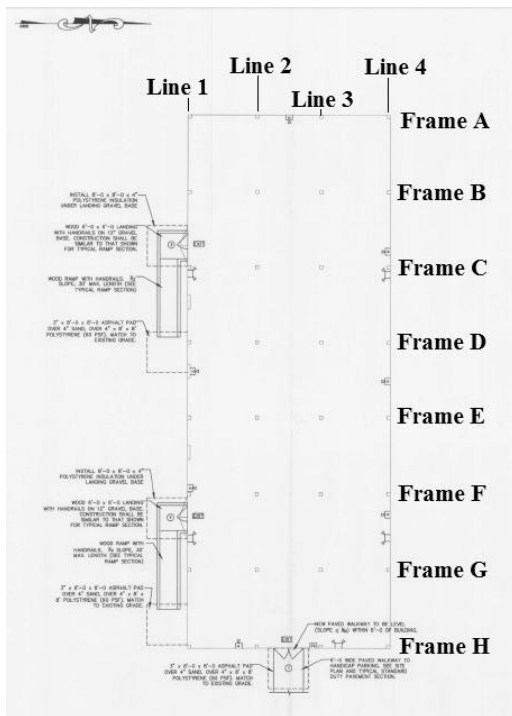
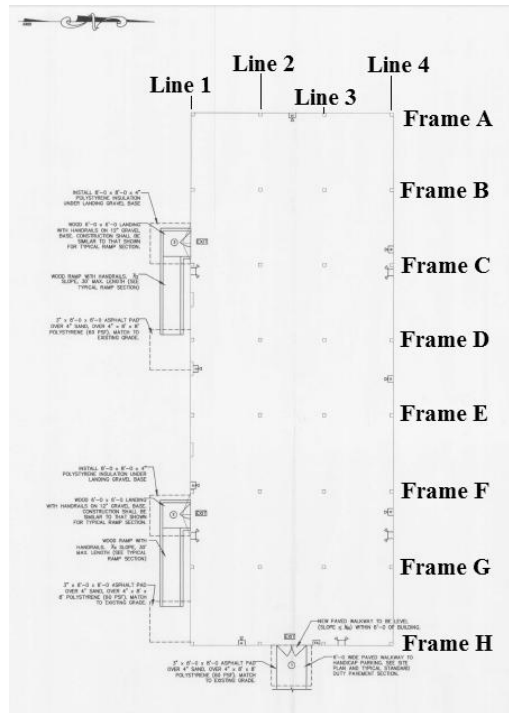
**Figure 3: Labeled Frames and Lines**

Figure 3: Labeled Frames and Lines below. The corner closest to the Ayers Island entrance is labeled Frame A, Line 1.

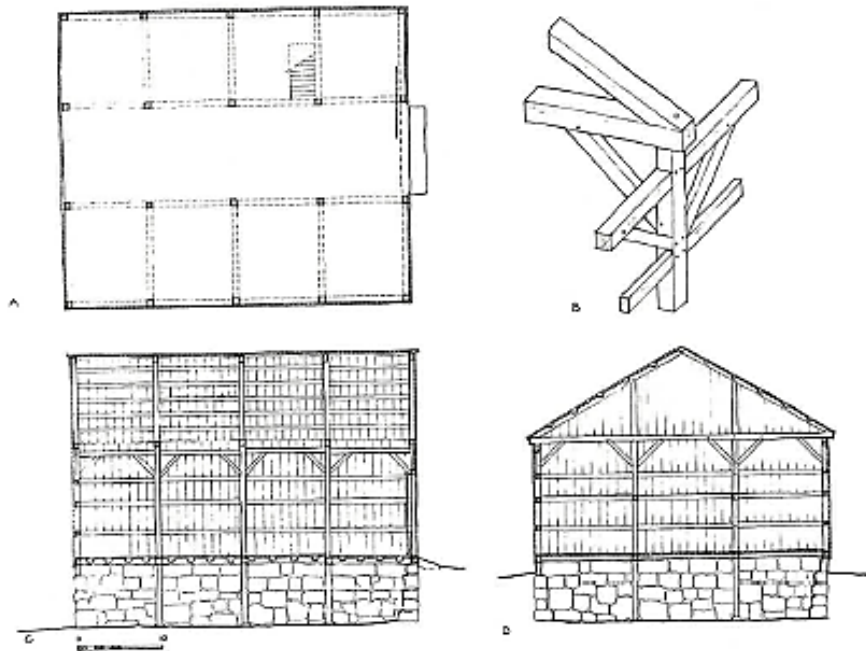
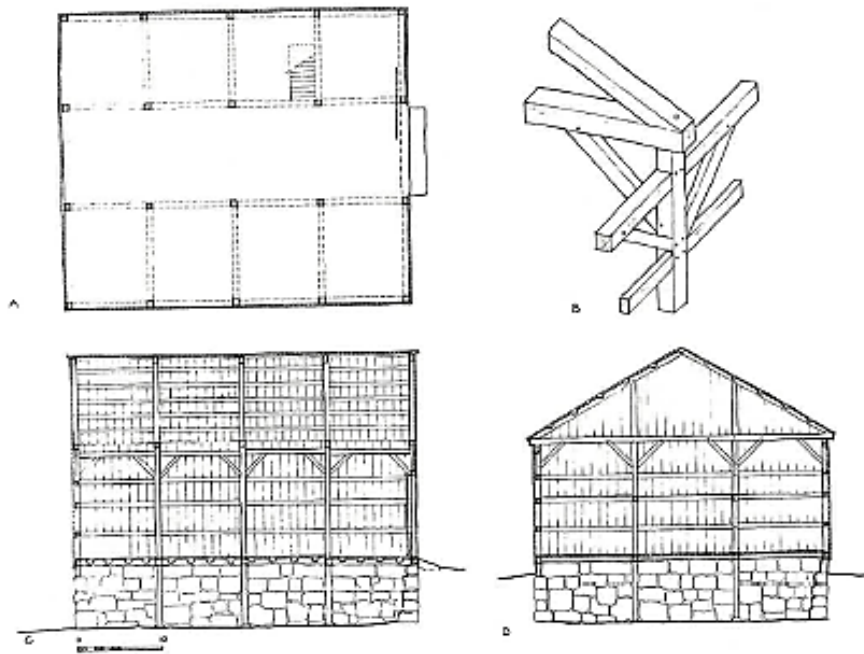
#### Figure 4: New England style barn

**The Ayers Island barn is a New England style barn, which is characterized by the door in the gable end. The New England style barn replaced the English style barn, which has the door in one of the side walls, as the most popular type of barn in New England by 1860 (Hubka, 1984, p. 52). The New England style barn is often three bays wide, as is the Ayers Island barn (Hubka, 1984, p.55). New England style barns that were built after 1840 often use 8 inch by 8 inch sawn members for the major structural members, which is the case on Ayers Island (Hubka, 1984, p.56). The barn on Ayers Island has framing for windows over the main doors and a cellar**

Fig. 45. A New England barn: A, plan; B, framing detail at plate; C, longitudinal section; D, transverse section. Sawyer-Black Farm, Sweden, Maine.

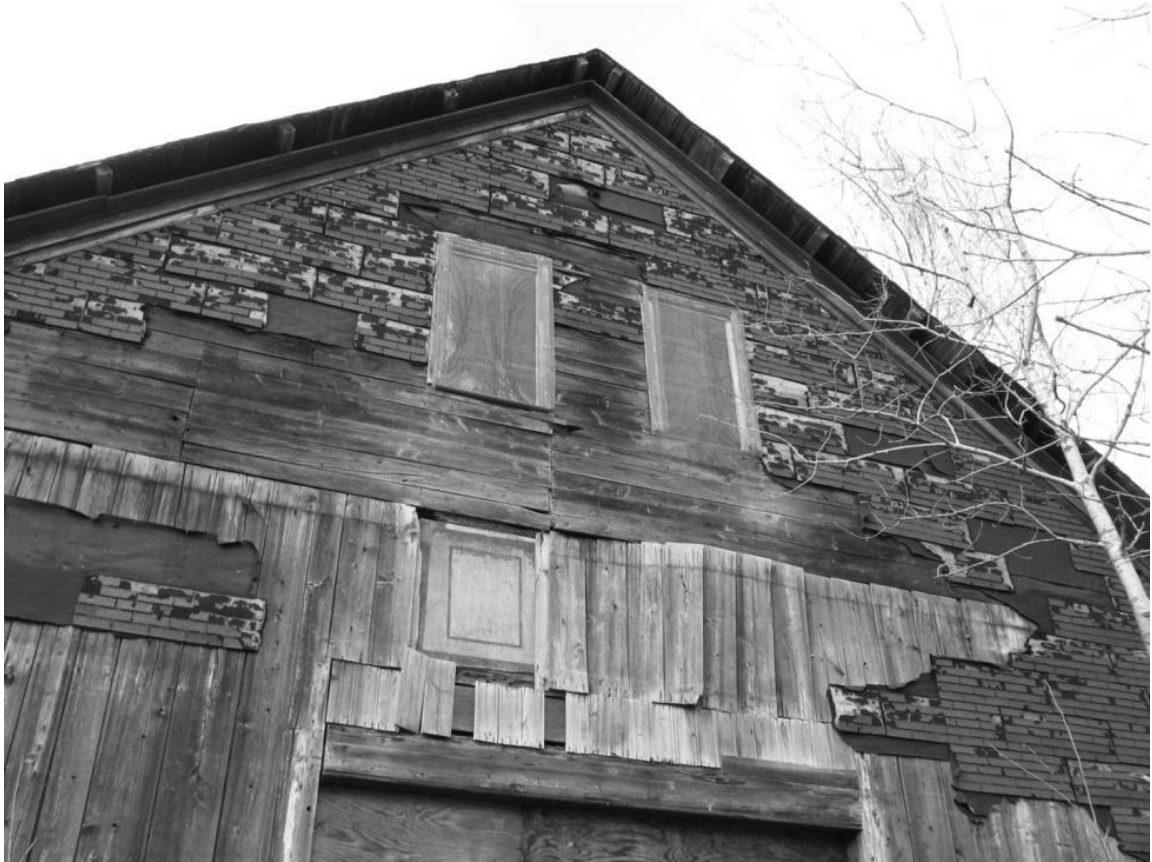
**Figure 5: Current Exterior of the Barn**

The faux brick siding has peeled off the side of the barn in many places. The boarding remains in good shape over most of the barn. There were only a few places where there

was evidence of rot. See Figure 5: Current Exterior of the Barn below, for an image of the peeling faux brick siding.

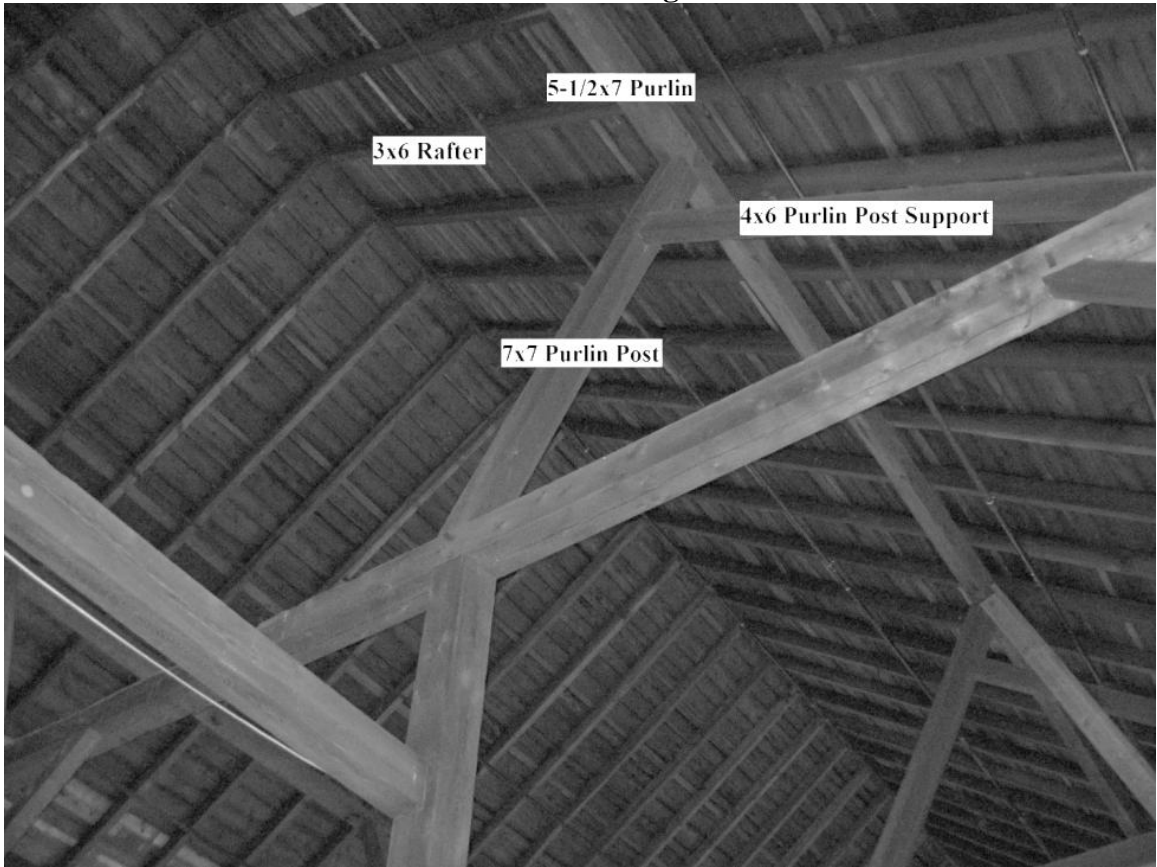
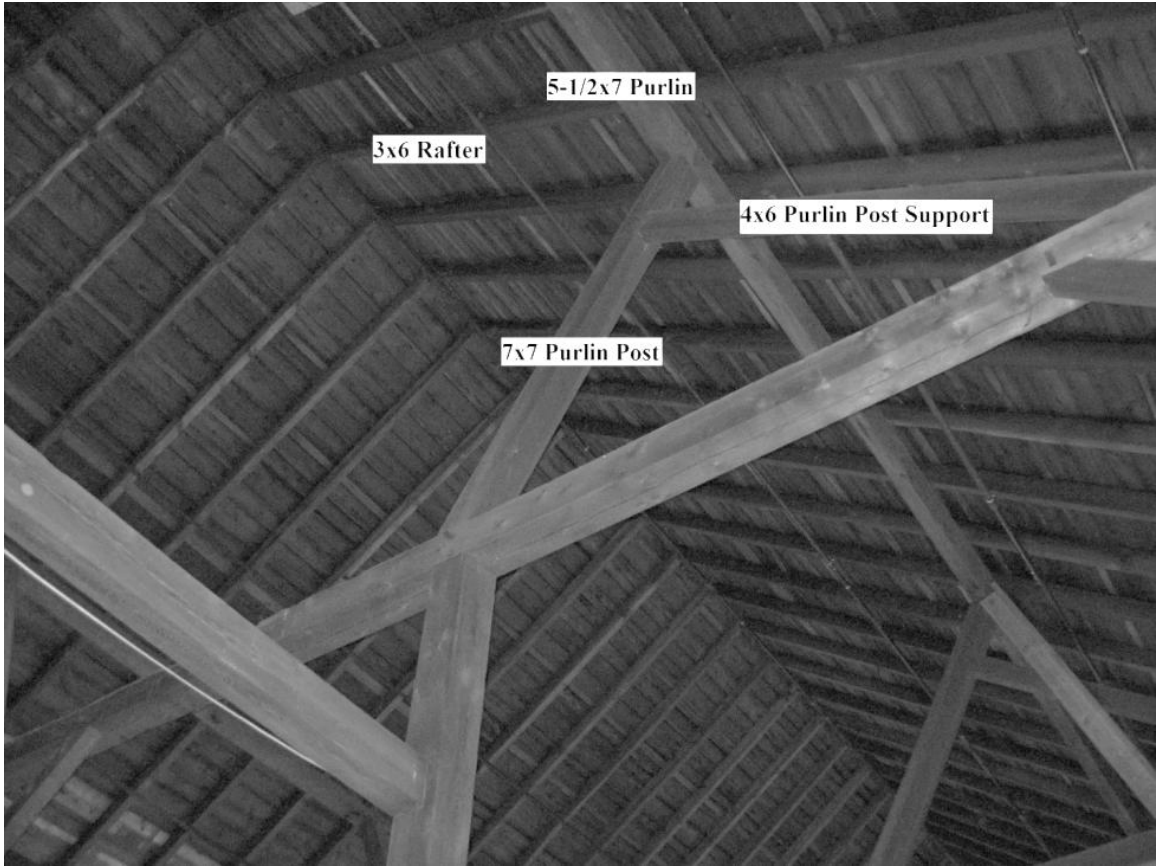
**Figure 6: Current Roof Framing**

**The barn on Ayers Island has a roof with a 9 on 12 pitch. The roofing includes: shingles, a layer of 1 inch boarding, 3 inch by 6 inch rafters at 27 inches on center, 5 ½ inch by 7 inch purlins and 8 inch by 8 inch eave beams. The boarding runs parallel to the ridge of the roof and is nailed to the rafters. The rafters are 27 feet long and run from the ridge line to the eave beam. The purlins run parallel to the ridge line and support the rafters at approximately the middle of their span. The eave beam is supported by an 8 inch by 8 inch cross beam, which is discussed below**

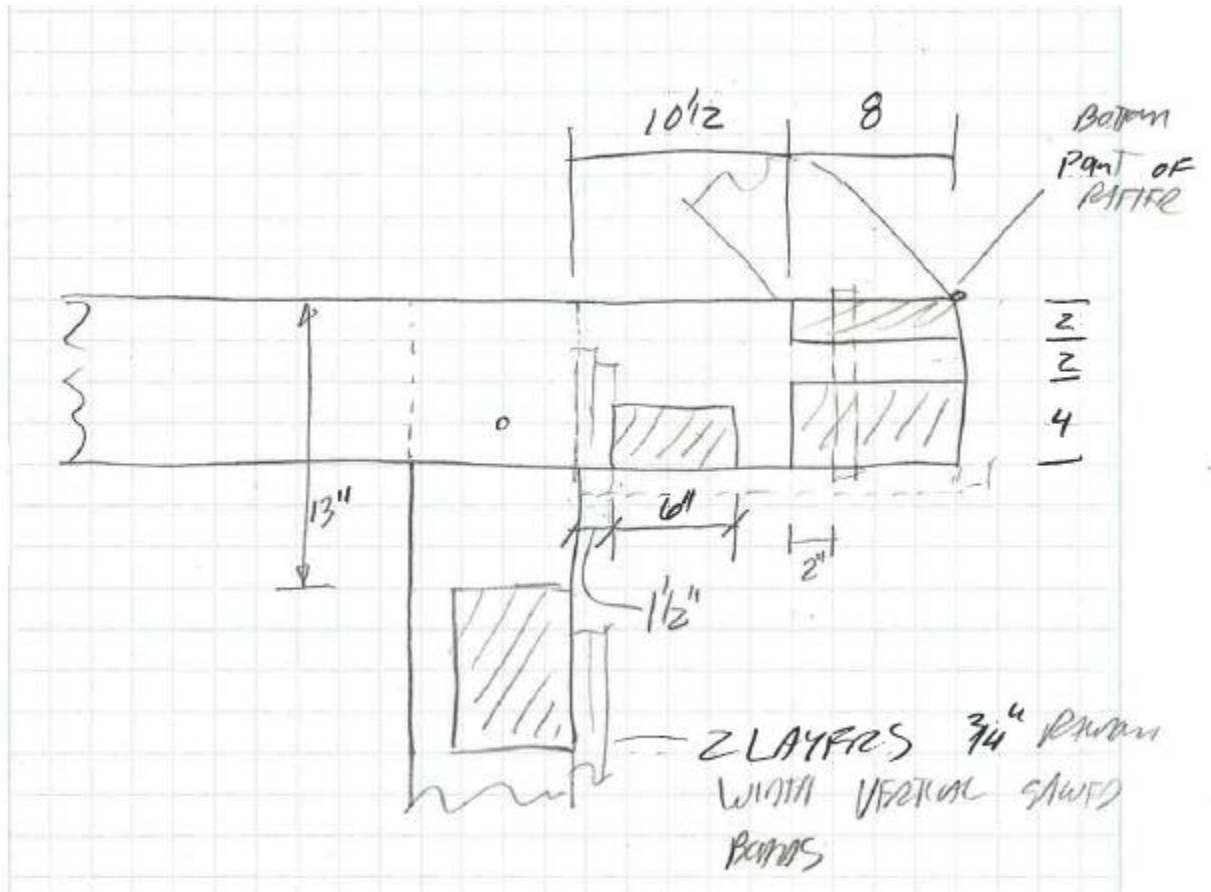
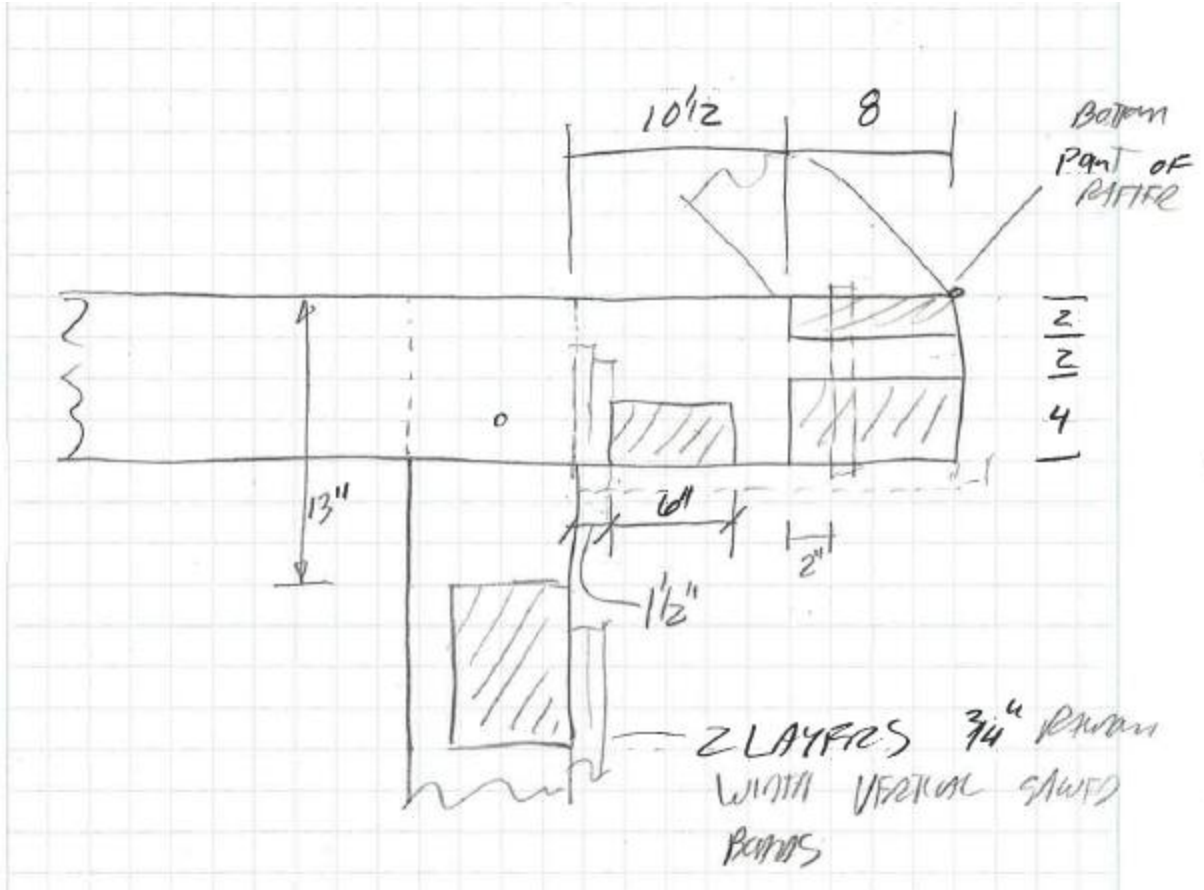
**Figure 7: Eave Beam Detail**

**The eave beam is an unusual piece of framing because it does not fall over the exterior wall line but is 18 inches out from the exterior wall. In most post and beam construction the rafters land on the exterior wall and a faux rafter or rafter tail is added for the overhang. In the Ayers Island barn the overhang is created by the**

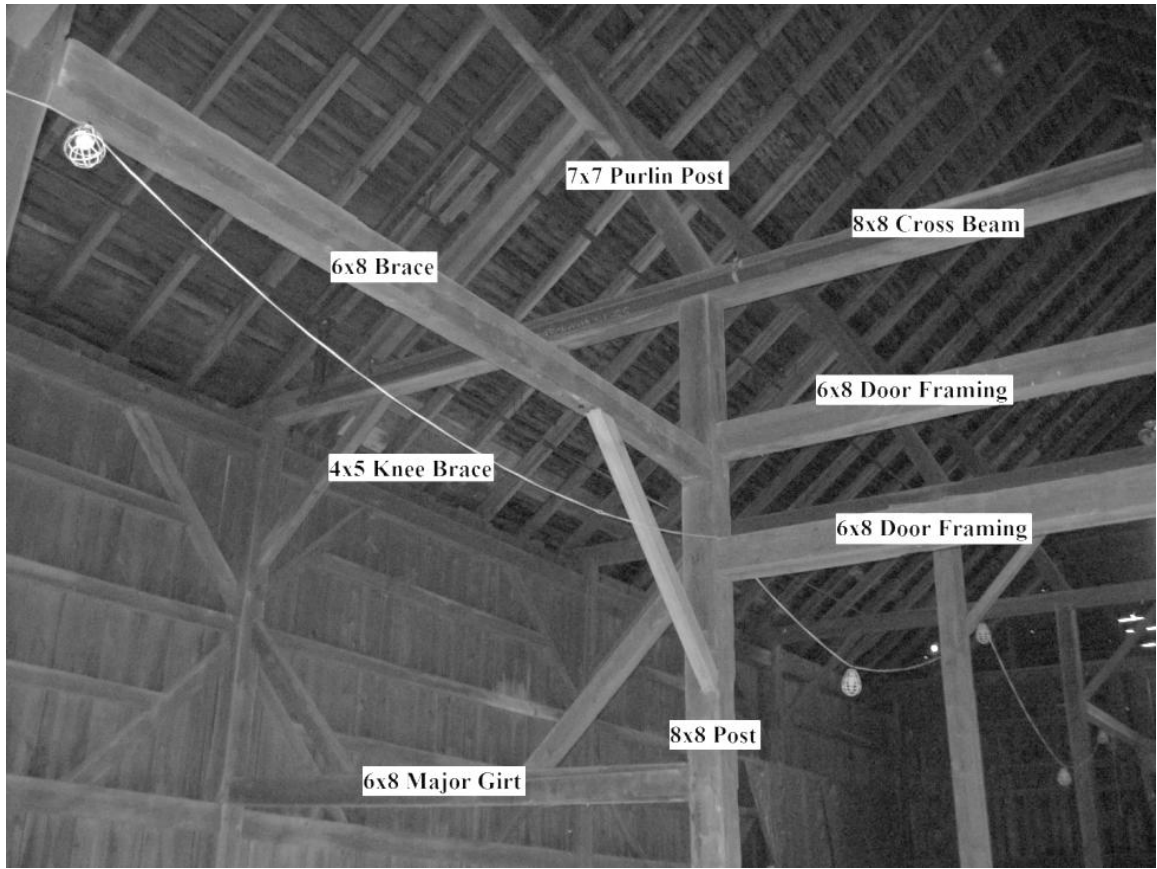
**Figure 9: Exterior Frame**

The interior framing includes two typical frames, an end frame and an interior frame. There are also two types of line framing, exterior and interior. A labeled exterior frame can be seen in Figure 9: Exterior Frame, below. The exterior frame includes: four 8 inch by 8 inch posts, a 8 inch by 8 inch cross beam, two 7 inch by 7 inch purlin posts, two 4 inch by 6 inch purlin post supports, two 6 inch by 8 inch beams framing the row of windows over the door, two 6 inch by 8 inch major girts, 4 inch by 5 inch minor girts, and eight 4 inch by 5 inch knee braces. Frames A, E and H are exterior frames.

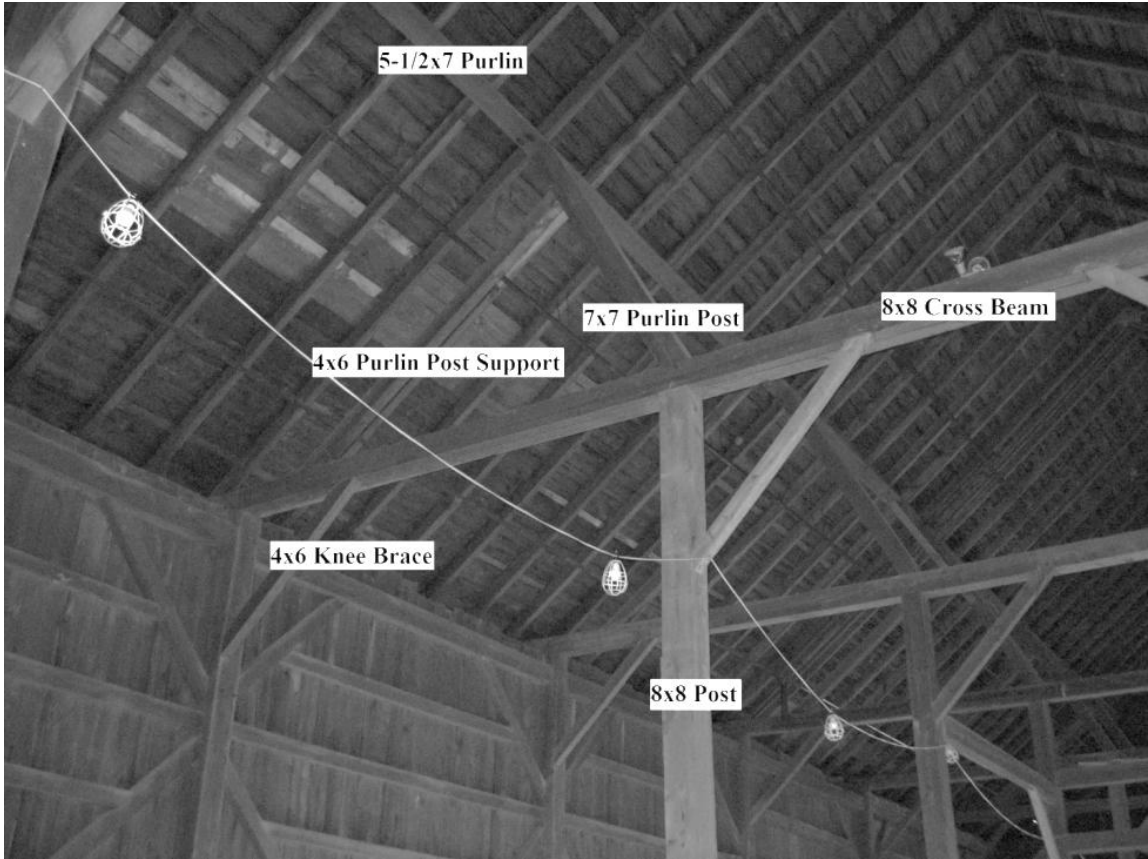
**Figure 10: Interior Frame**

A labeled interior frame can be seen in Figure 10: Interior Frame, below. The interior frame includes: four 8 inch by 8 inch posts, a 8 inch by 8 inch cross beam, two 7 inch by 7 inch purlin posts, two 4 inch by 6 inch purlin post supports, and four 4 inch by 5 inch knee braces. Frames B, C, D, and F are interior frames.

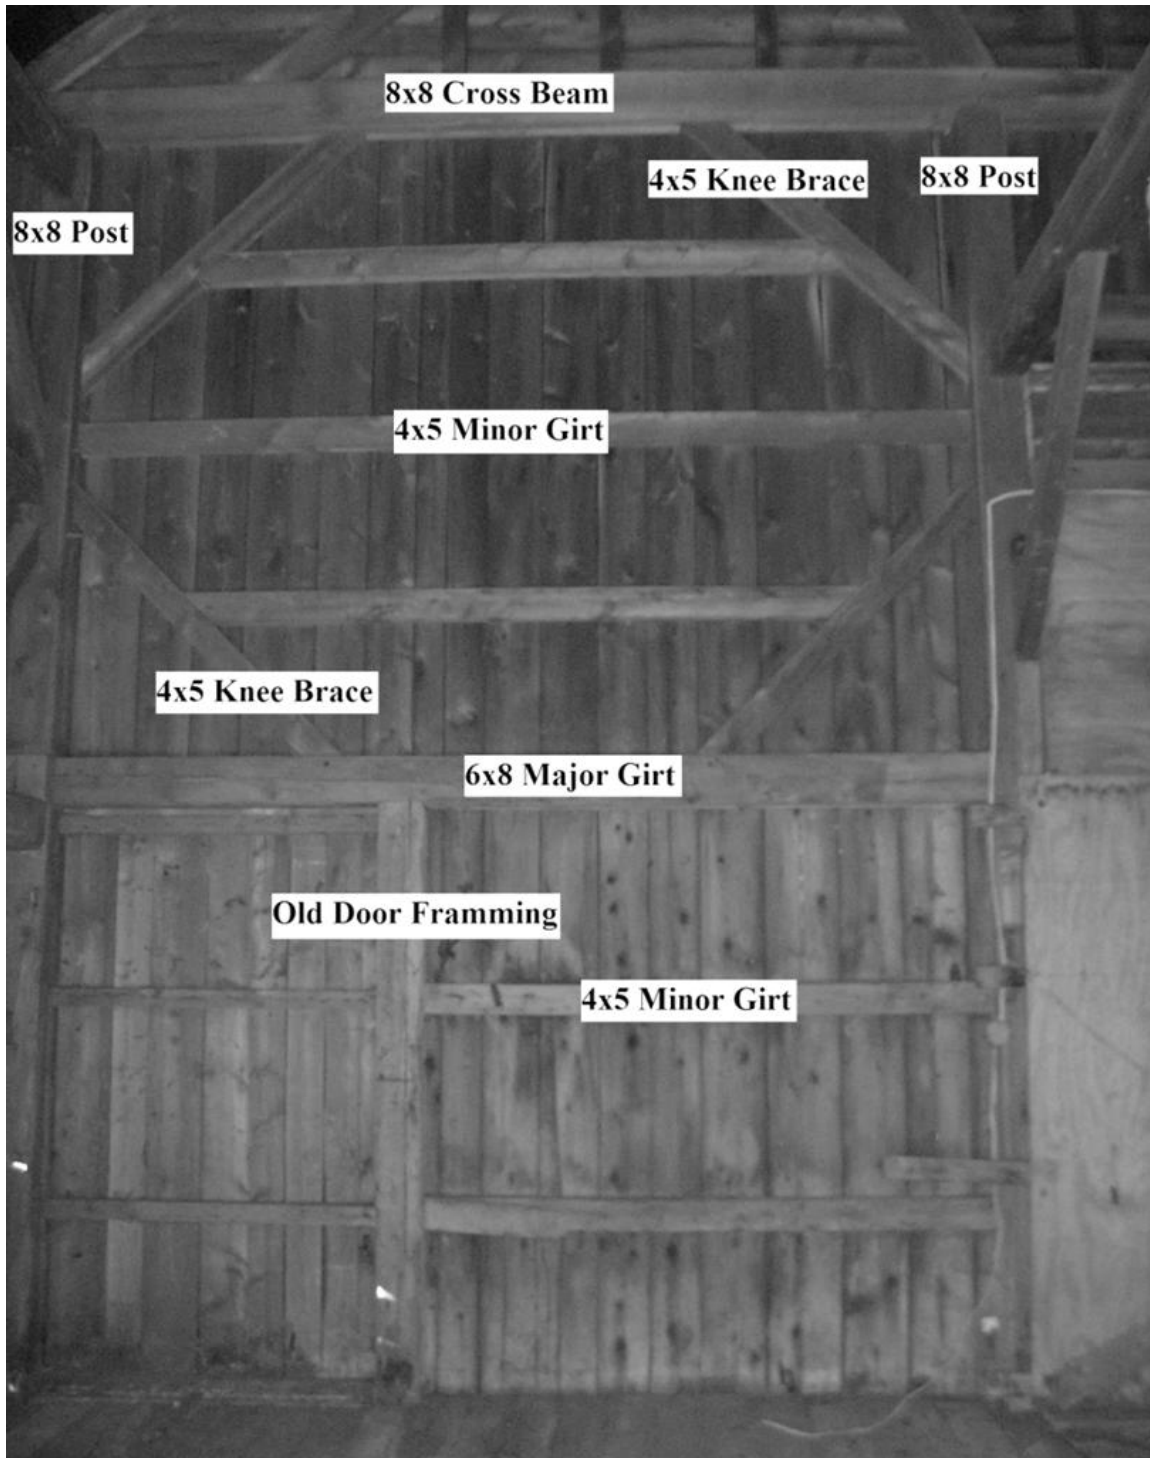
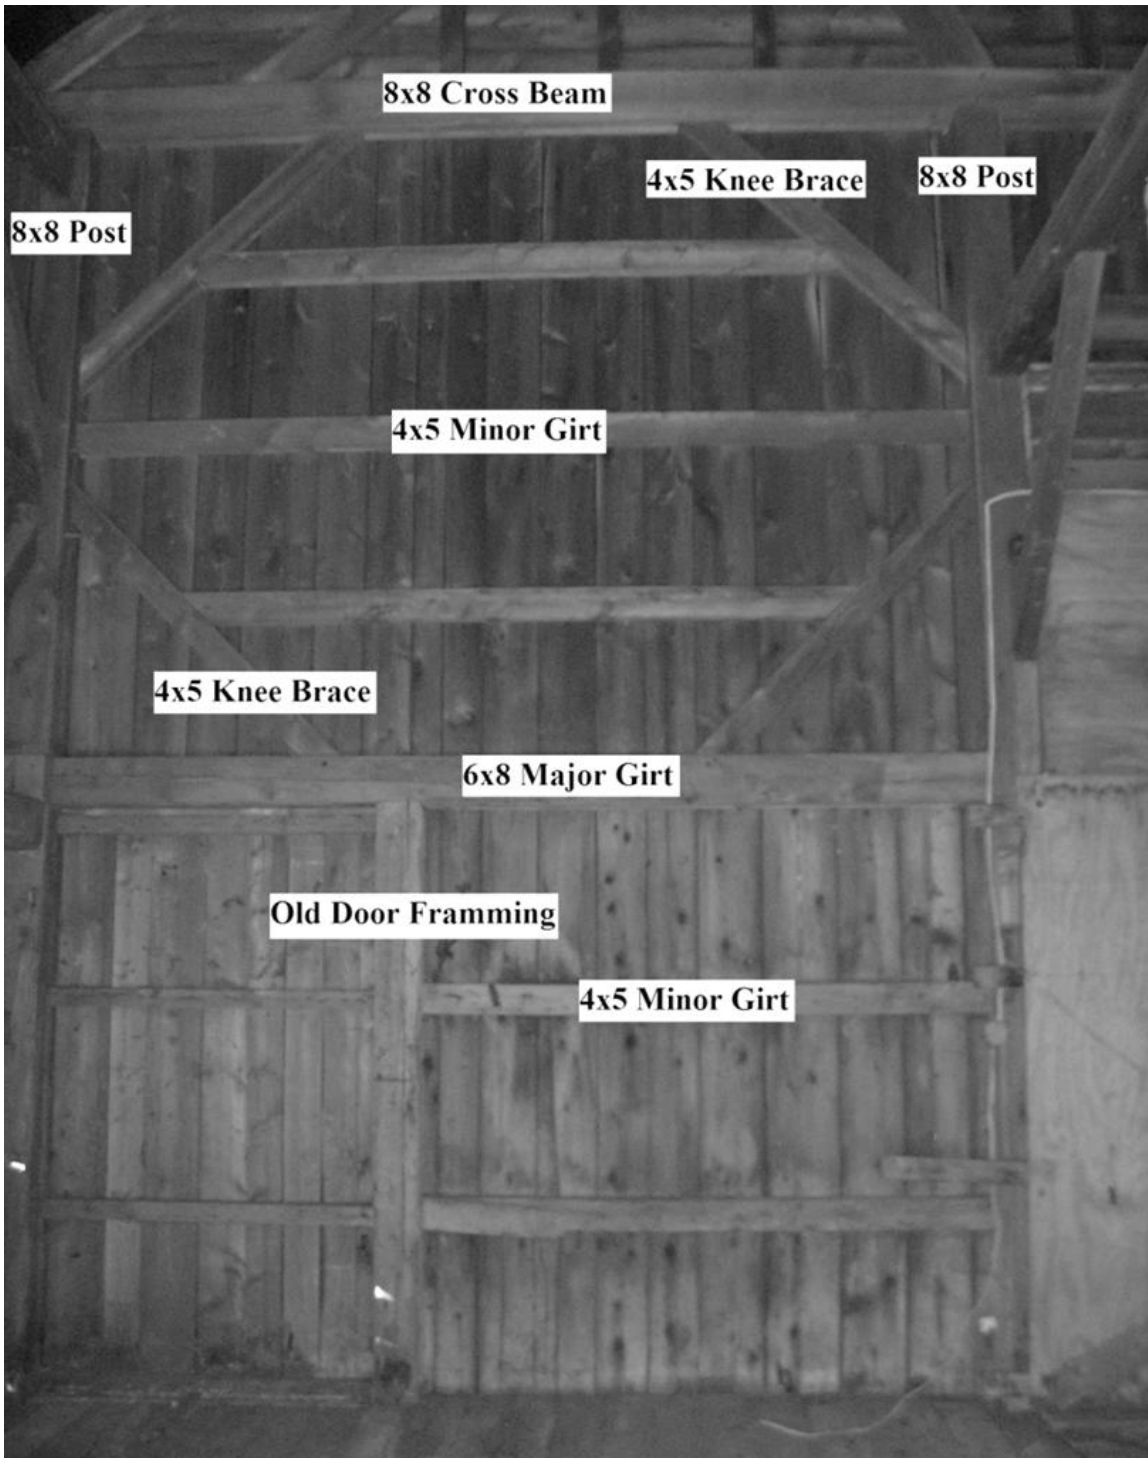
**Figure 11: Exterior Wall Framing**

Figure 11: Exterior Wall Framing below. The exterior wall lines include two 6 inch by 8 inch major girts and 4 inch by 5 inch minor girts which run between the exterior posts in each frame. There are also knee braces that connect the major girts and the exterior posts.

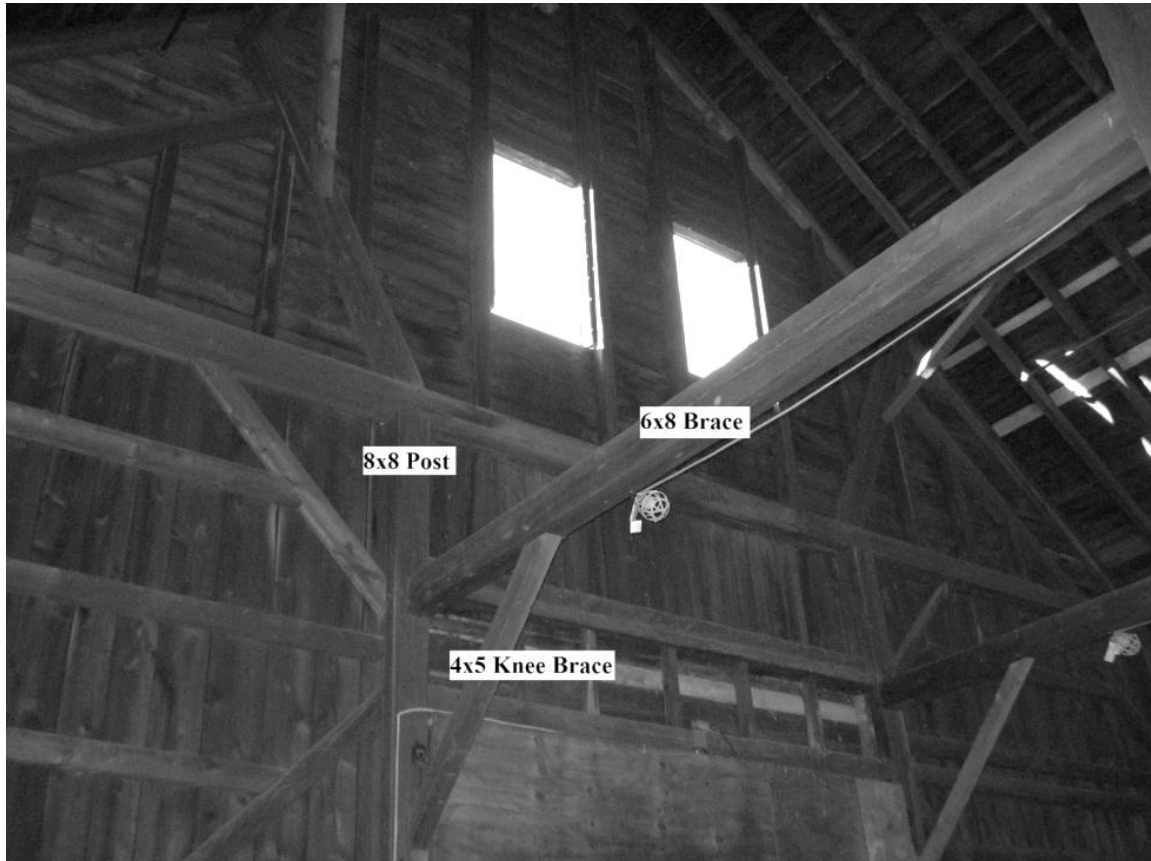
**Figure 12: Interior Line Framing**

The interior line framing consists of 6 inch by 8 inch braces and knee braces connecting the exterior frames to the interior frame adjacent to them. A labeled interior line can be seen in Figure 12: Interior Line Framing below.

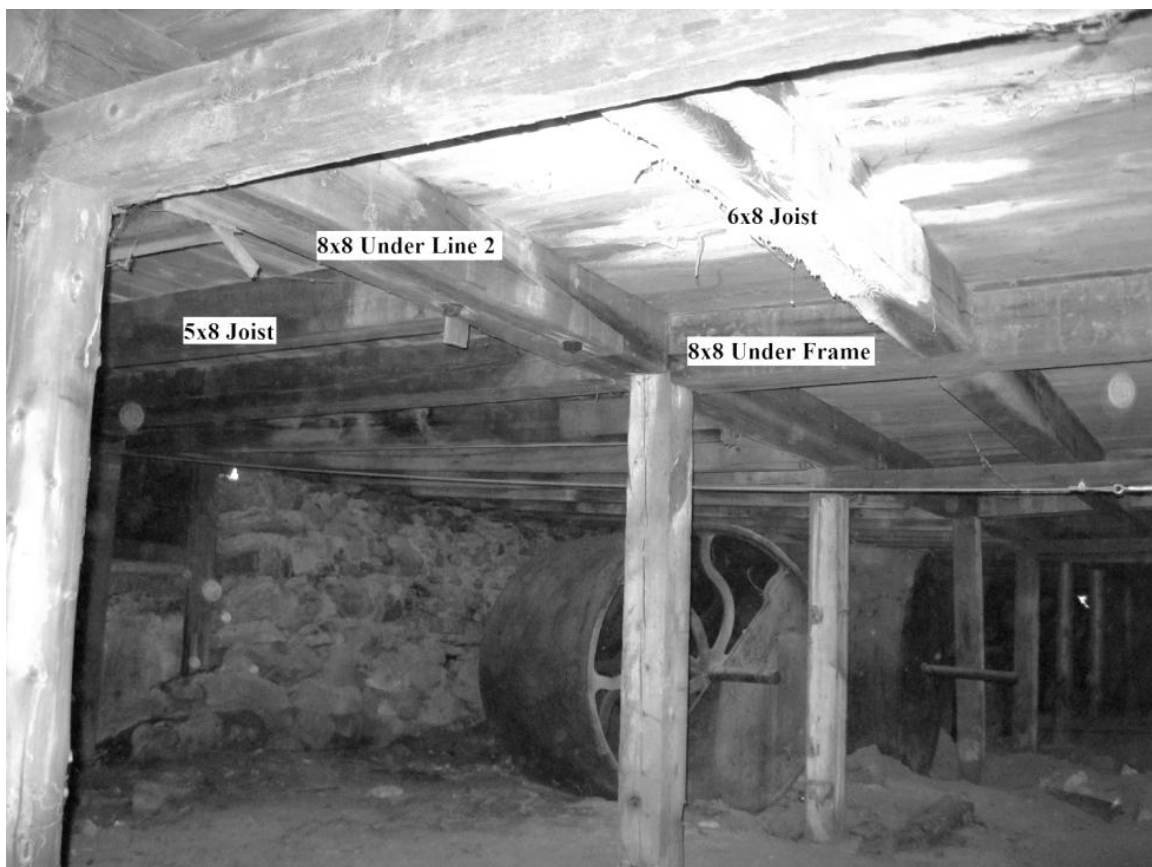
**Figure 13: Floor Framing**

The floor framing includes: 3 inch thick floor random width boards, 8 inch by 8 inch sill plates around the exterior, 8 inch by 8 inch beams under the frame lines, 8 inch by 8 inch beams under the interior lines, 5 inch by 8 inch joists at 3 feet on center between Line 1 and Line 2 and between Line 3 and Line 4, and 6 inch by 8 inch joists at 38 inches on center that run between the frame lines. See Figure 13: Floor Framing below, for a labeled drawing of the floor framing.

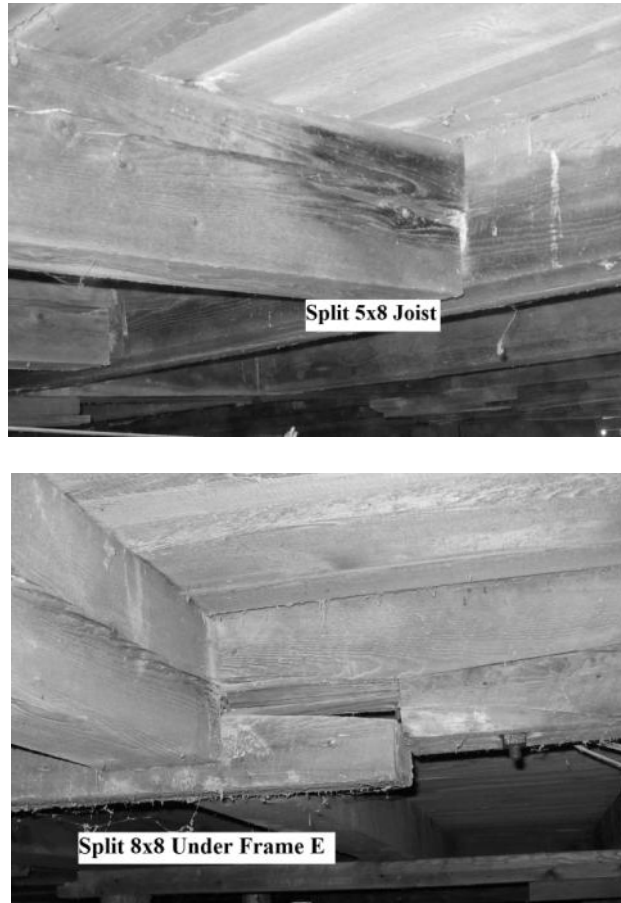
**Figure 14: Issues with Floor Framing**

There are several issues with the current floor framing. The 8 inch by 8 inch beam that runs under Frame E has split in the center. Also, many of the 5 inch by 8 inch joists and the 6 inch by 8 inch joists are split where they frame into the beams. See Figure 14:

There are several changes necessary to make the existing barn structurally sound according to IBC 2009 loads. The 5 inch by 8 inch floor joists and the 6 inch by 8 inch floor joists are inadequate. Adding center supports to the floor joists will make them adequate. This solution is in line with the current framing of the floor because these supports have already been added in several places.

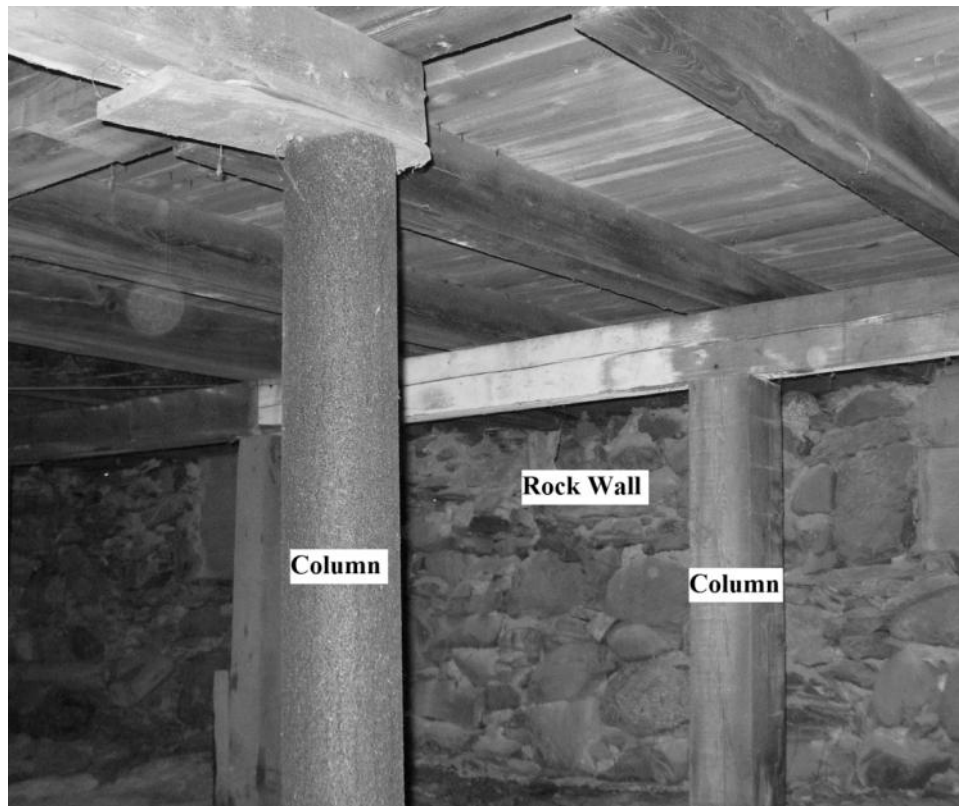
**Figure 15: Foundation**

The foundation of the barn on Ayers Island includes an exterior rock wall and columns under the interior posts that land on 2 foot by 2 foot concrete footings. See Figure 15: Foundation below for a labeled image.

The columns under the interior posts are a mismatched collection of steel and wood shapes. Most of the concrete footings have become buried under the dirt floor of the cellar. Analysis of the foundation was excluded from the scope of this project.

The foundation of the existing barn is a rock wall around the perimeter and posts that land on 2 foot by 2 foot footings on the ground. The capacity and stability of this foundation was not analyzed in this report, however, it is very important. If the foundation is not adequate the barn cannot be used as an event center. An analysis of the existing foundation should be performed by a licensed professional engineer to ensure that it is adequate for the new use of the barn.
