Archaeological Recovery at Quebrada de la Vaca, Chala, Peru

Francis A. Riddell

ARCHAEOLOGICAL RECOVERY AT QUEBRADA DE LA VACA, CHALA, PERU

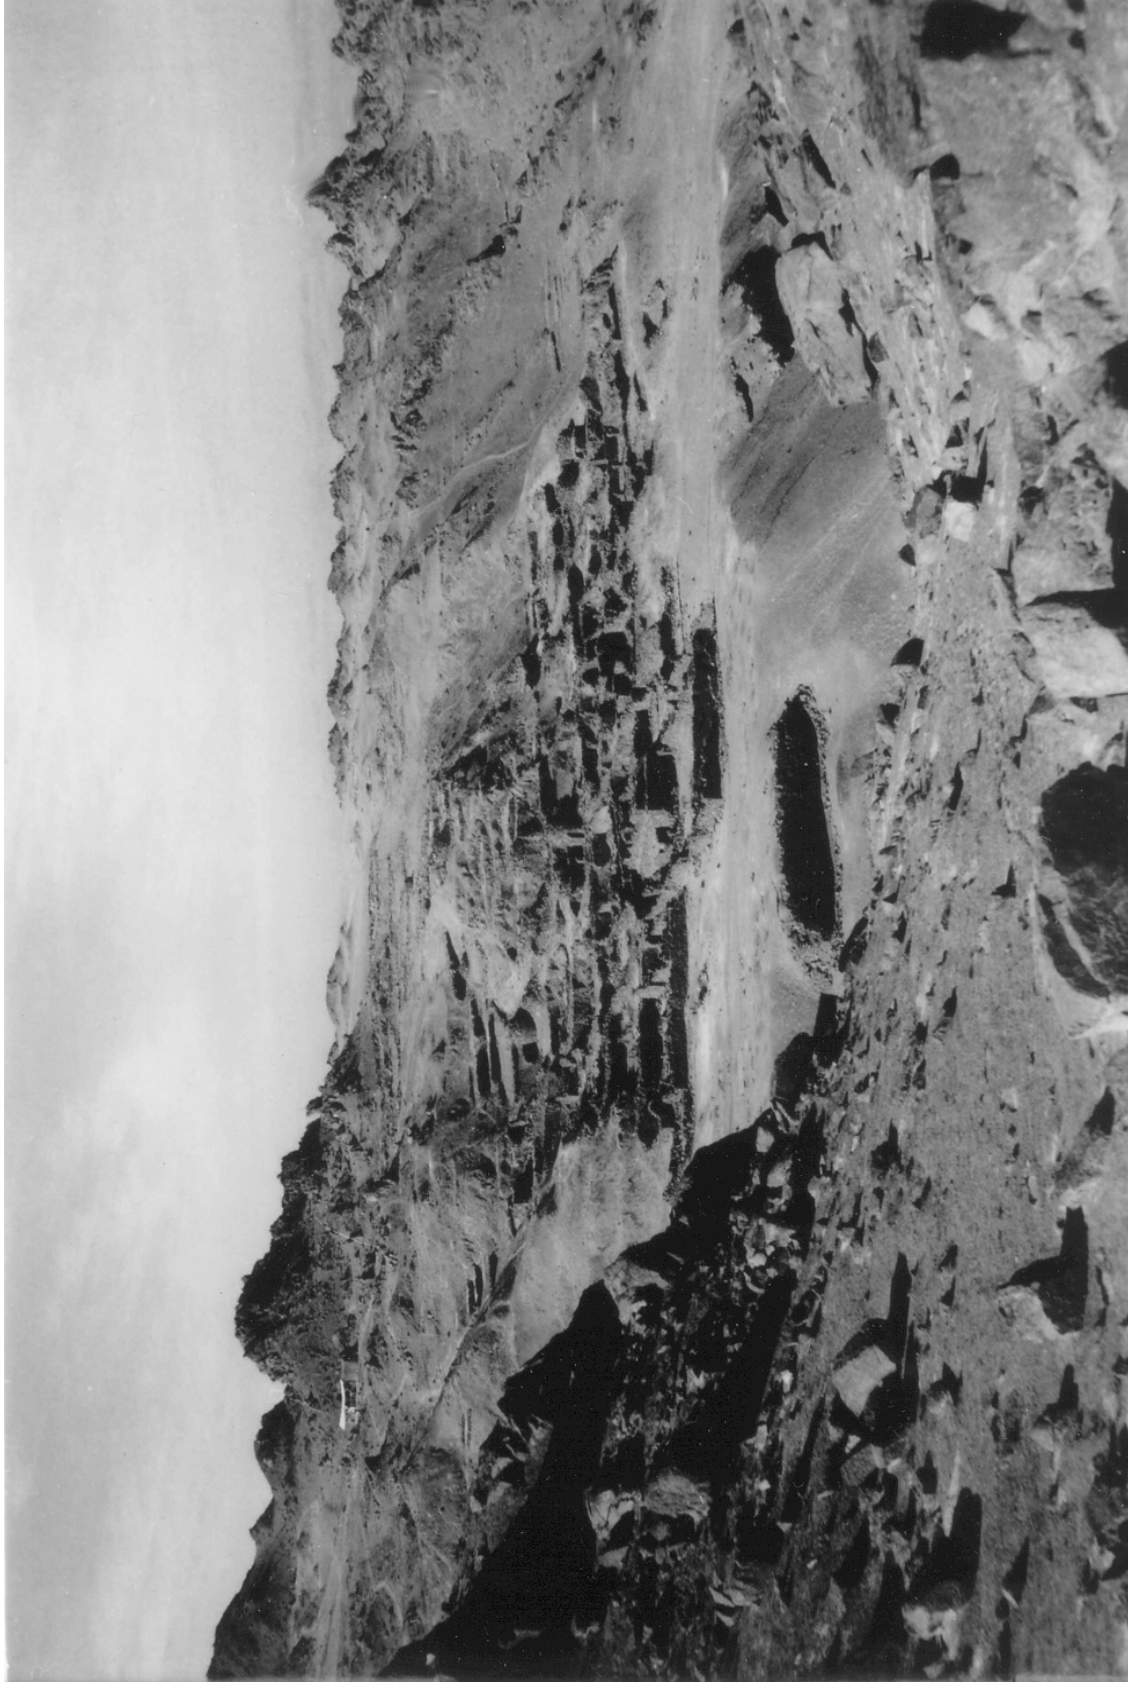
Figure 2. The ruins of Quebrada de la Vaca looking south. For scale note the small white rectangle in the upper left corner. It is the excavators' tent (photograph by F. A. Riddell, courtesy of the California Institute for Peruvian Studies).

The site of Quebrada de la Vaca (PV77-3) is a few kilometers west (up coast) from the town of Chala in the Department of Arequipa on the south coast of Peru (Figures 1 and 2). It is also called Puerto Inca. Max Uhle visited Quebrada de la Vaca in 1905 (Rowe 1956:138). However, interest in the site developed following Victor von Hagen's decision to make investigations there an aspect of his study of the Inca road system (von Hagen 1955). Although the ruins were known locally, they were rediscovered by von Hagen during a reconnaissance flight over the Chala region in 1954.

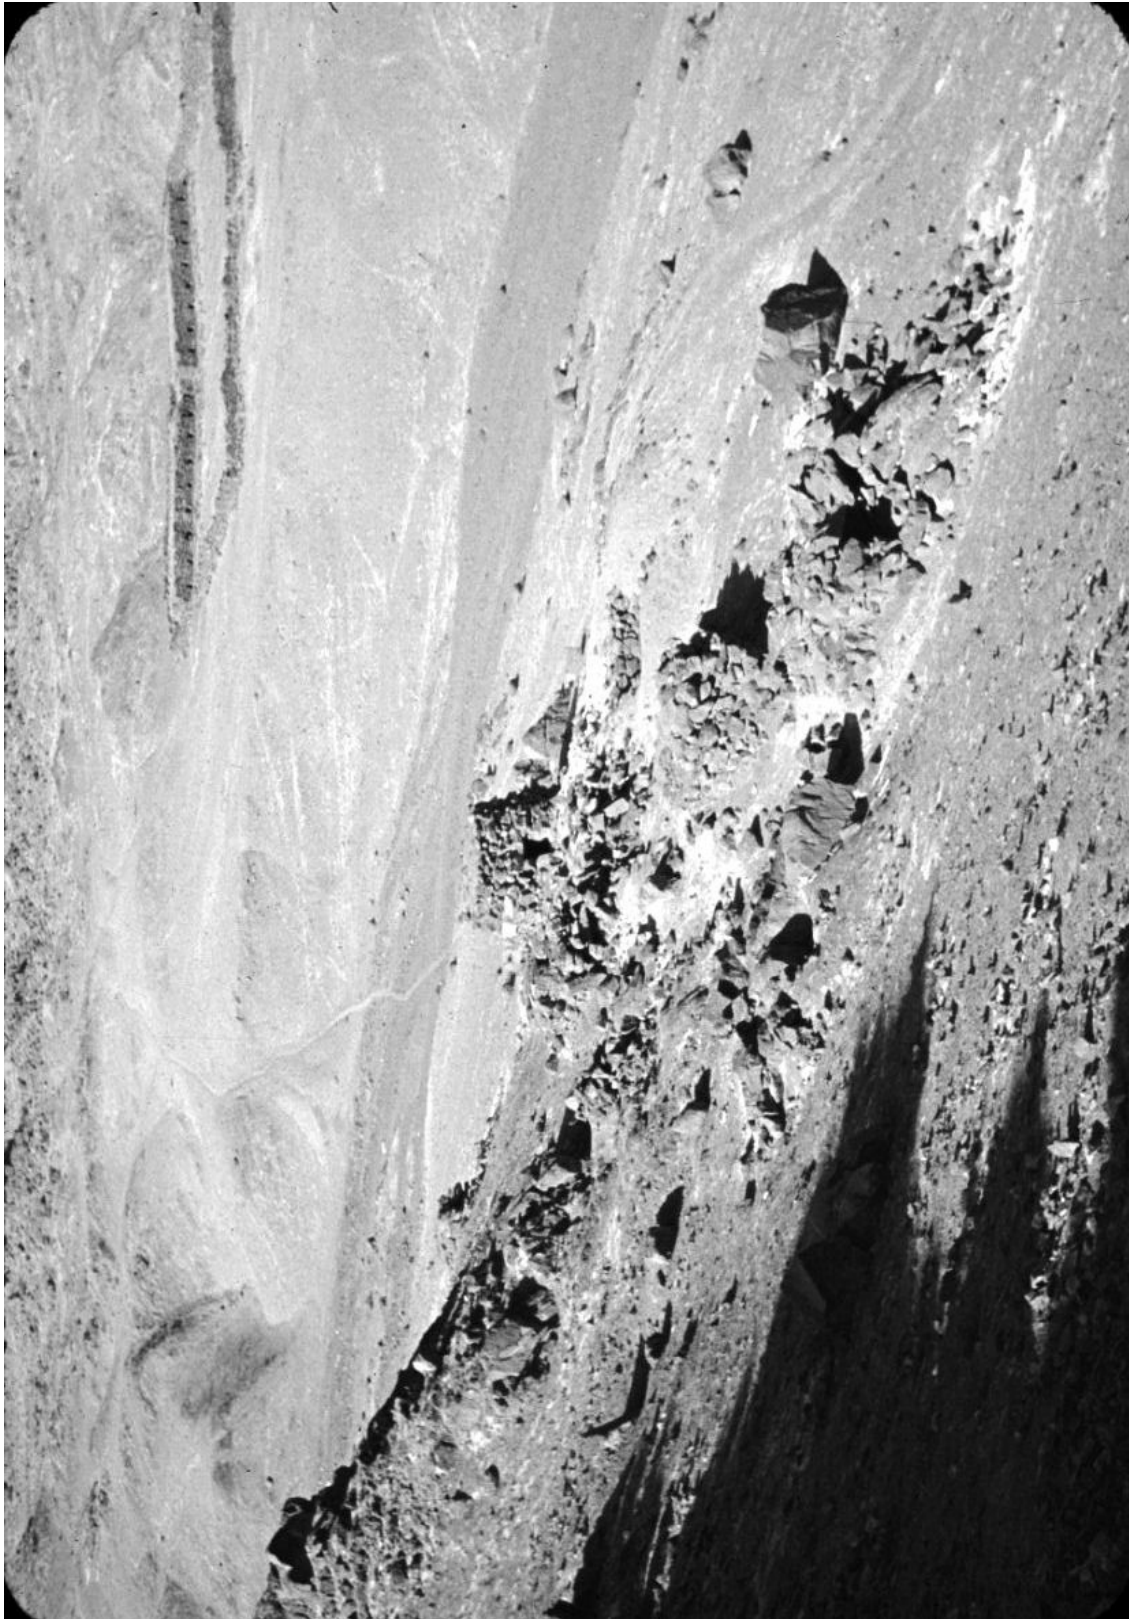
Figure 5. Quebrada de la Vaca. Chullpas are in the foreground. The Rectangular Storage Area is in the distance at the viewer's upper right hand corner (photograph by F. A. Riddell, 1954, courtesy of the California Institute for Peruvian Studies).

Of outstanding interest is the rather formalized storage area to one side of the habitation portion of the site which we called the Rectangular Storage Area. We made a detailed study of this structure in 1954, collecting volumetric data on its 17 chambers. This architectural feature stood to one side of the main habitation area (Figure 5). Later excavations by Trimborn's team revealed *algarrobo* (probably *Prosopis* sp.) seeds, ají (*Capsicum* sp.), corn cobs and quinoa seeds (Trimborn 1988/89:41). The Rectangular Storage Area certainly served as a storage facility, but it also may have been used for ritual activities, as suggested by Urton (Urton 1990:190-193; see also Trimborn 1985: plan 4, 1988/89: plano 4).

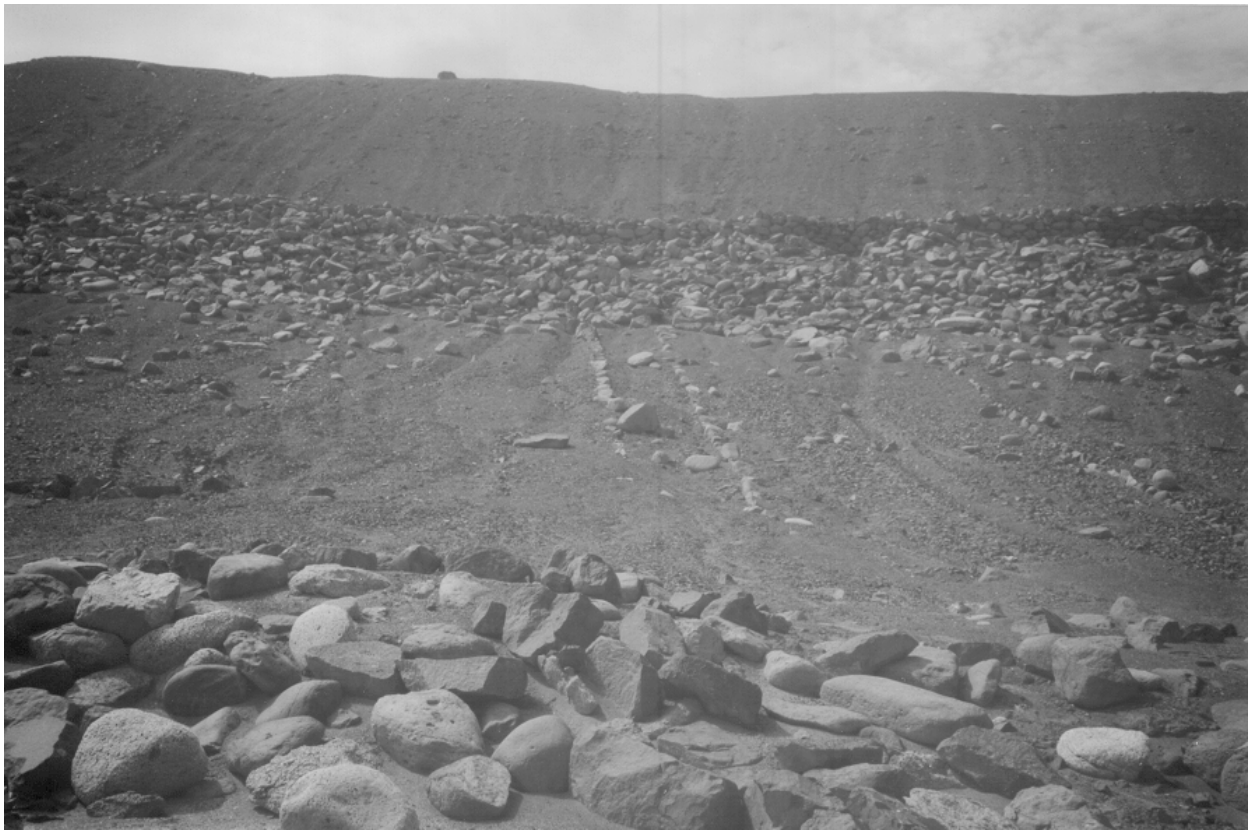
Figure 6. Parara Depósito (photograph by John C. Schaller, 1999).

Parara Depósito. According to Schaller (personal communication with the editors 29 November, 2006) the Parara Depósito is less well preserved than Quebrada de La Vaca West (see below) but the general trapezoidal outline of the structure is still evident (Figure 6). It measures 40m north-to-south along the back wall and 20m along its south side. It is oriented west-to-east, facing west at 33.5°, thus also facing the Quebrada de Chala. The structure's rear is nestled into the sand hill immediately to its east. Unlike at Quebrada de la Vaca and Chala Viejo Antiguo, there is no apparent habitation zone surrounding the structure, although there is some other architecture, including small structures in front of it that probably served as above-ground storage units. There is evidence for similar above-ground storage units at the rear of the structure, but they have all collapsed.

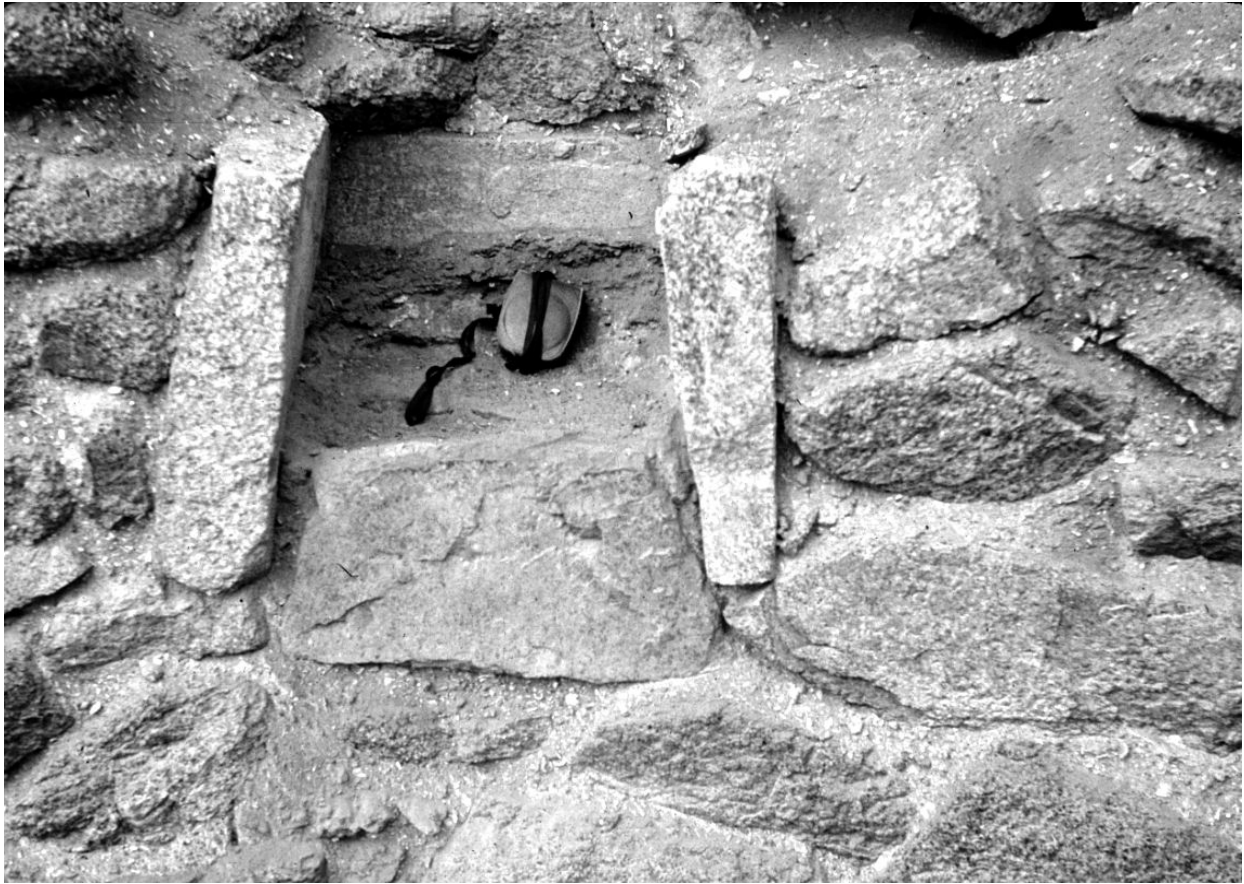
Figure 7. Trapezoidal niche at Quebrada de la Vaca (photograph by F. A. Riddell. 1954, courtesy of the California Institute for Peruvian Studies).

There are three niches in the west wall. The two northernmost niches are 70cm above the floor and the southernmost niche is 80cm above it. Such trapezoidal niches are common in these ruins and widespread in Inca architecture generally (Figure 7).

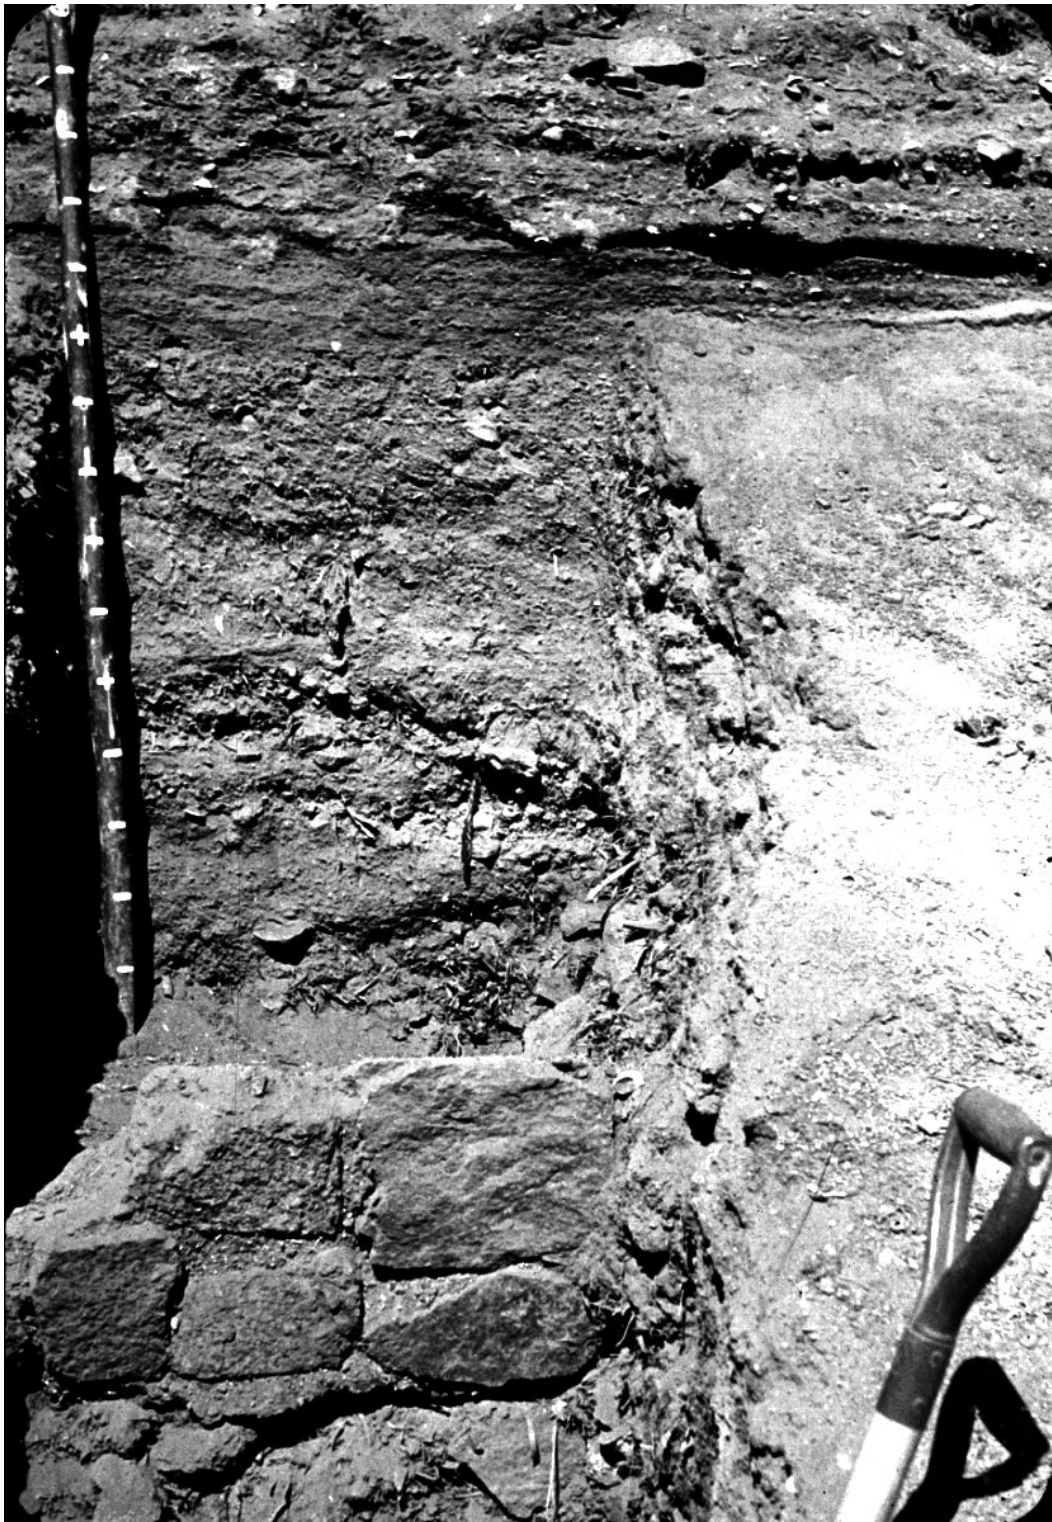
Figure 9. Test Trench 2, Quebrada de la Vaca. Note low retaining wall beneath midden (photograph by F. A. Riddell, 1954, courtesy of the California Institute for Peruvian Studies).

After proceeding for about 1m into the slope, we encountered the outside face of a retaining wall about .5m high, built in the same style as the rest of the ruins (Figure 9). Its interstices were filled with organic matter and other refuse. It had been built atop an earlier wall of angular, unmortared stones. We exposed the face of the wall from its top to below its base, a distance of about 40cm. The wall seems to have been built to retain midden and was buried by the disposal of garbage and subsequent downward drift of the midden from the slopes above it.

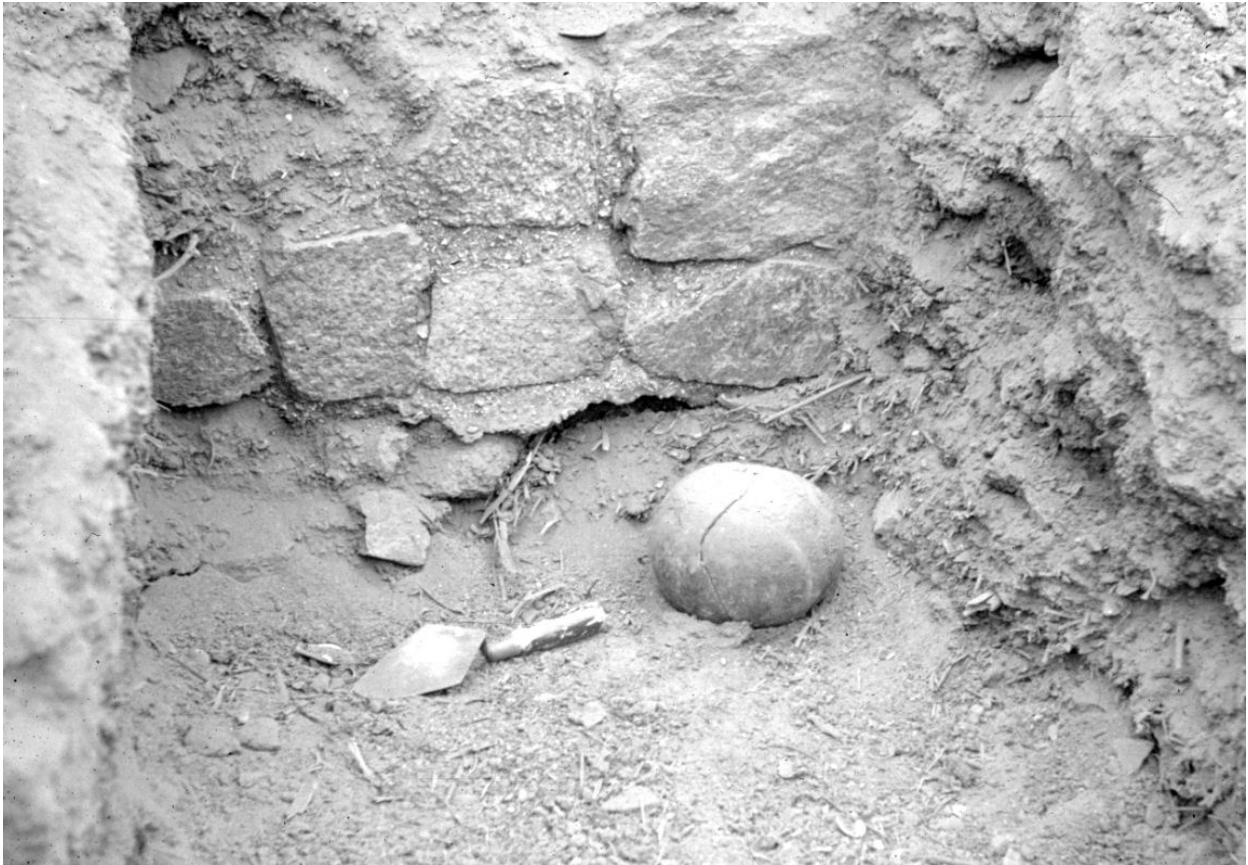
Figure 10. Test trench 2, Quebrada de la Vaca. Gourd bowl. See Figures 9-12 (photograph by F. A. Riddell. 1954, courtesy of the California Institute for Peruvian Studies).

Just below the base of the wall and 5cm out from its face we found a gourd bowl with a diameter of c. 20cm. It was resting in the mouth down position (Figure 10). The gourd contained a small, rectangular cloth bag made from an old blanket or similar cloth (Figure 11). The cloth was tied up with cord. The bag held fossilized sea urchin spines, a strand of human hair bound with cotton thread, tufts of human hair, three small, dark, water worn pebbles, and two fragments of greenstone, a copper ore. Beneath the bag was a section of cane split lengthwise so that a bag could be stuffed into the hollow cane (Figure 12). The pieces of cane had been re-fitted together and bound with a string of human hair. We sent these associated artifacts to the Museo Regional de Ica with the rest of the Quebrada de la Vaca collections (Appendix 1). Investigations in 1990 provided the details given here.

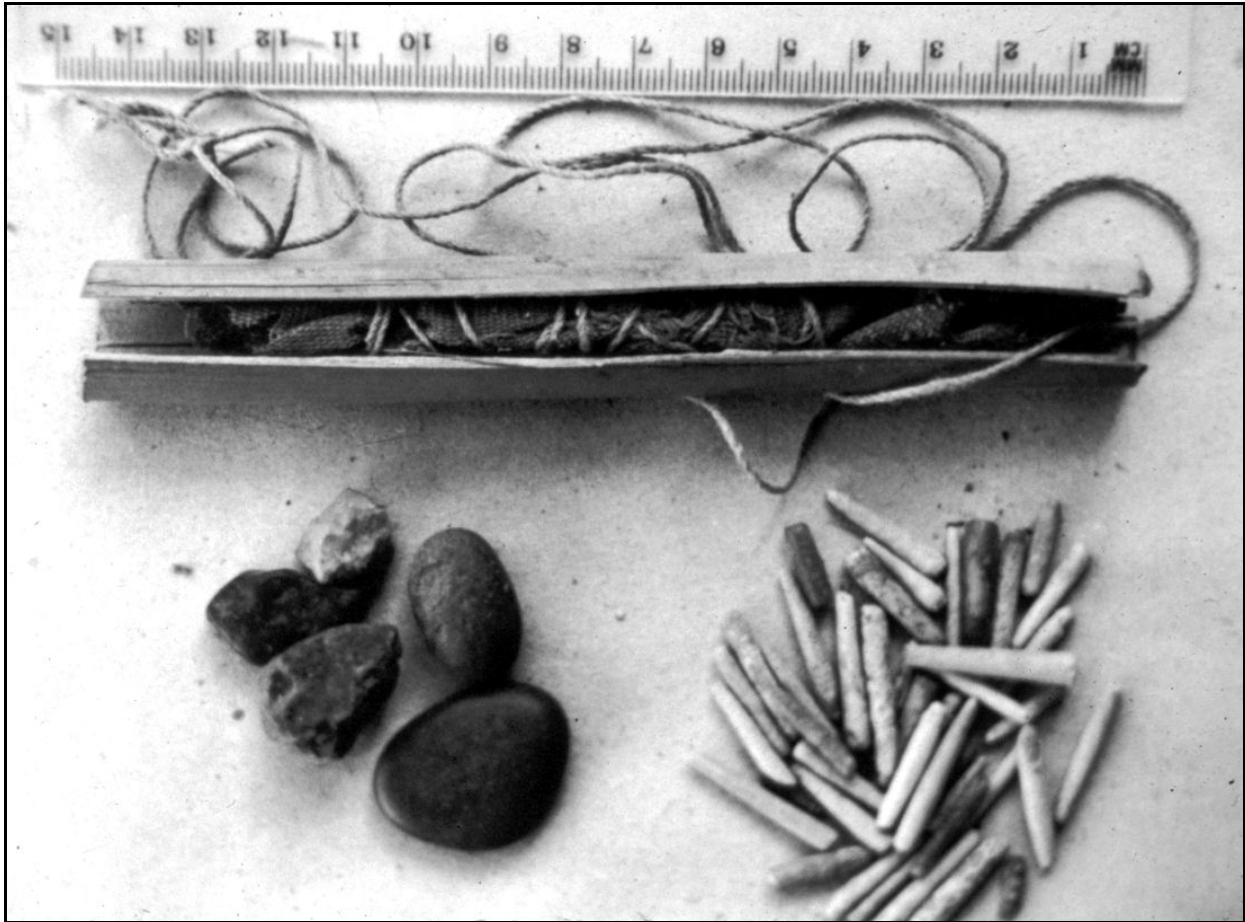
Figure 12. Test Trench 2, Quebrada de la Vaca. Partial contents of bag shown in Figure 11. At the lower left are three small, dark, water-worn pebbles and two fragments of greenstone, a copper ore. At the lower right are fossilized sea urchin spines. At the top is a section of cane split lengthwise so that a bag could be stuffed into it. The bag shown in Figure 11 also held a strand of human hair bound with cotton thread and tufts of human hair (photograph by F. A. Riddell, 1954, courtesy of the California Institute for Peruvian Studies).

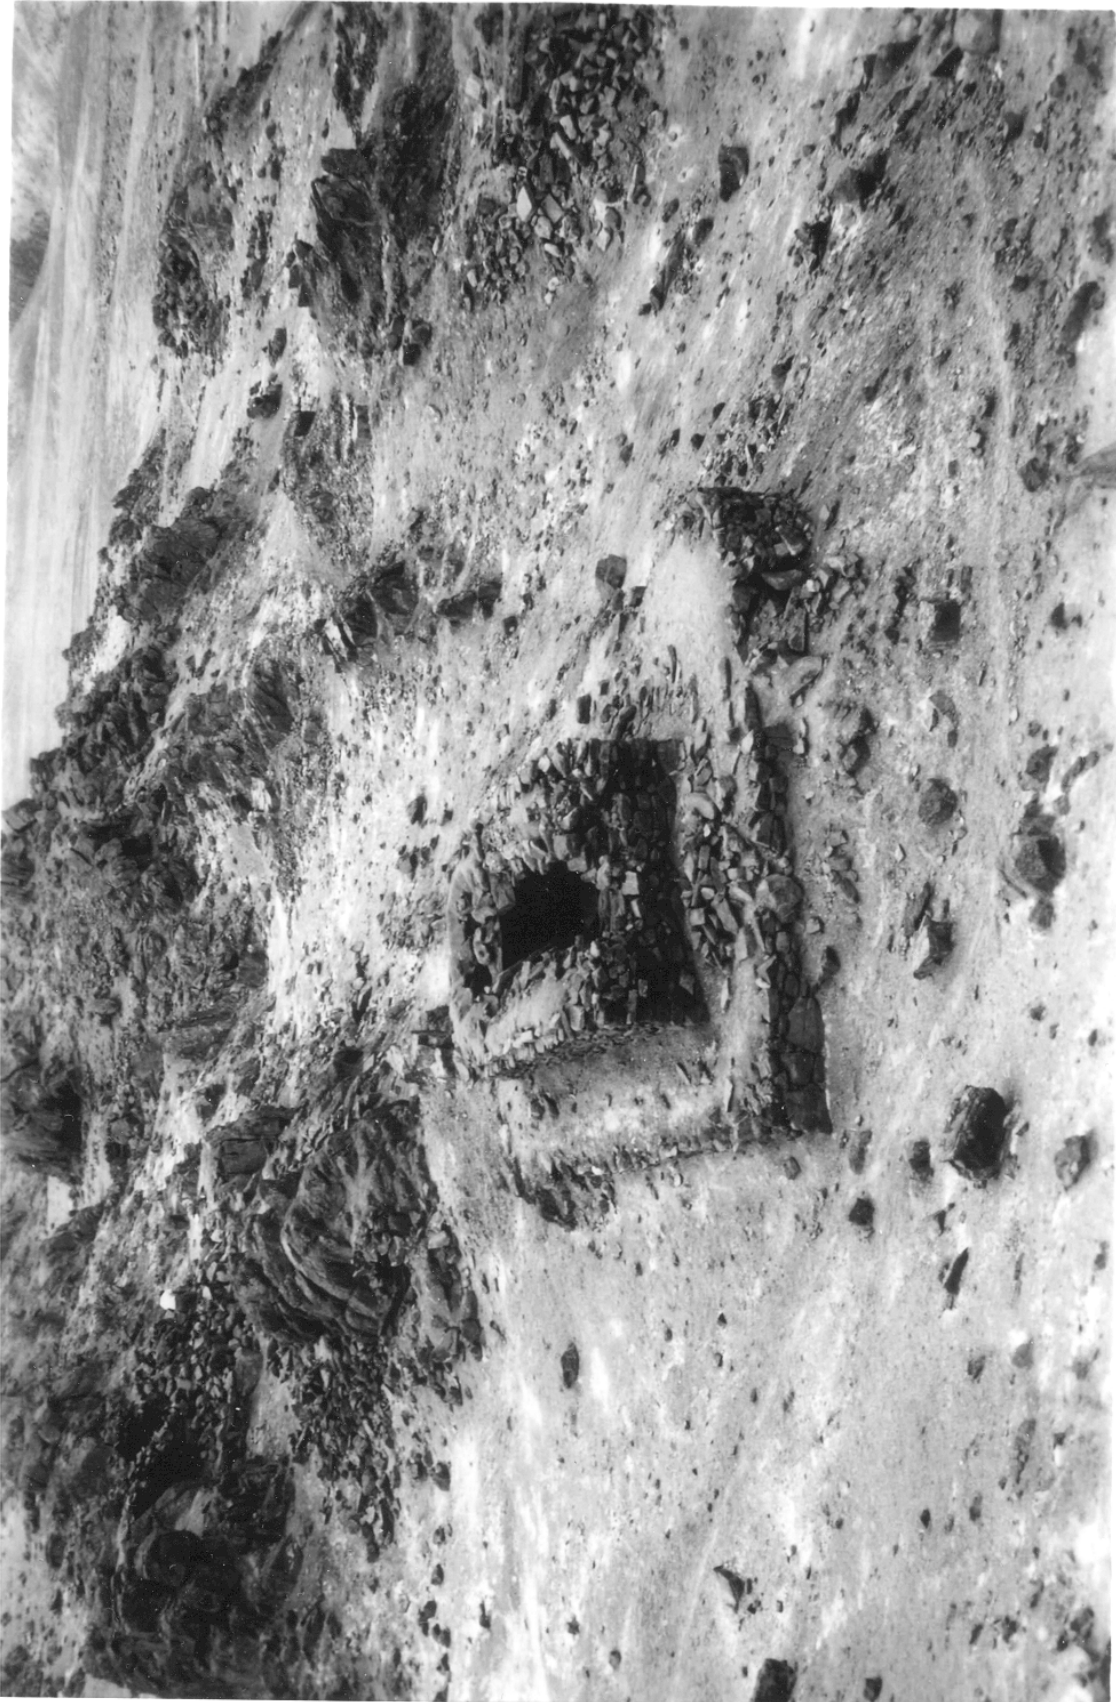
Figure 13. Tomb 1 (Burial House 1) at Quebrada de la Vaca West, looking east
(photograph by F. A. Riddell, 1954. courtesy of the California Institute for Peruvian Studies).

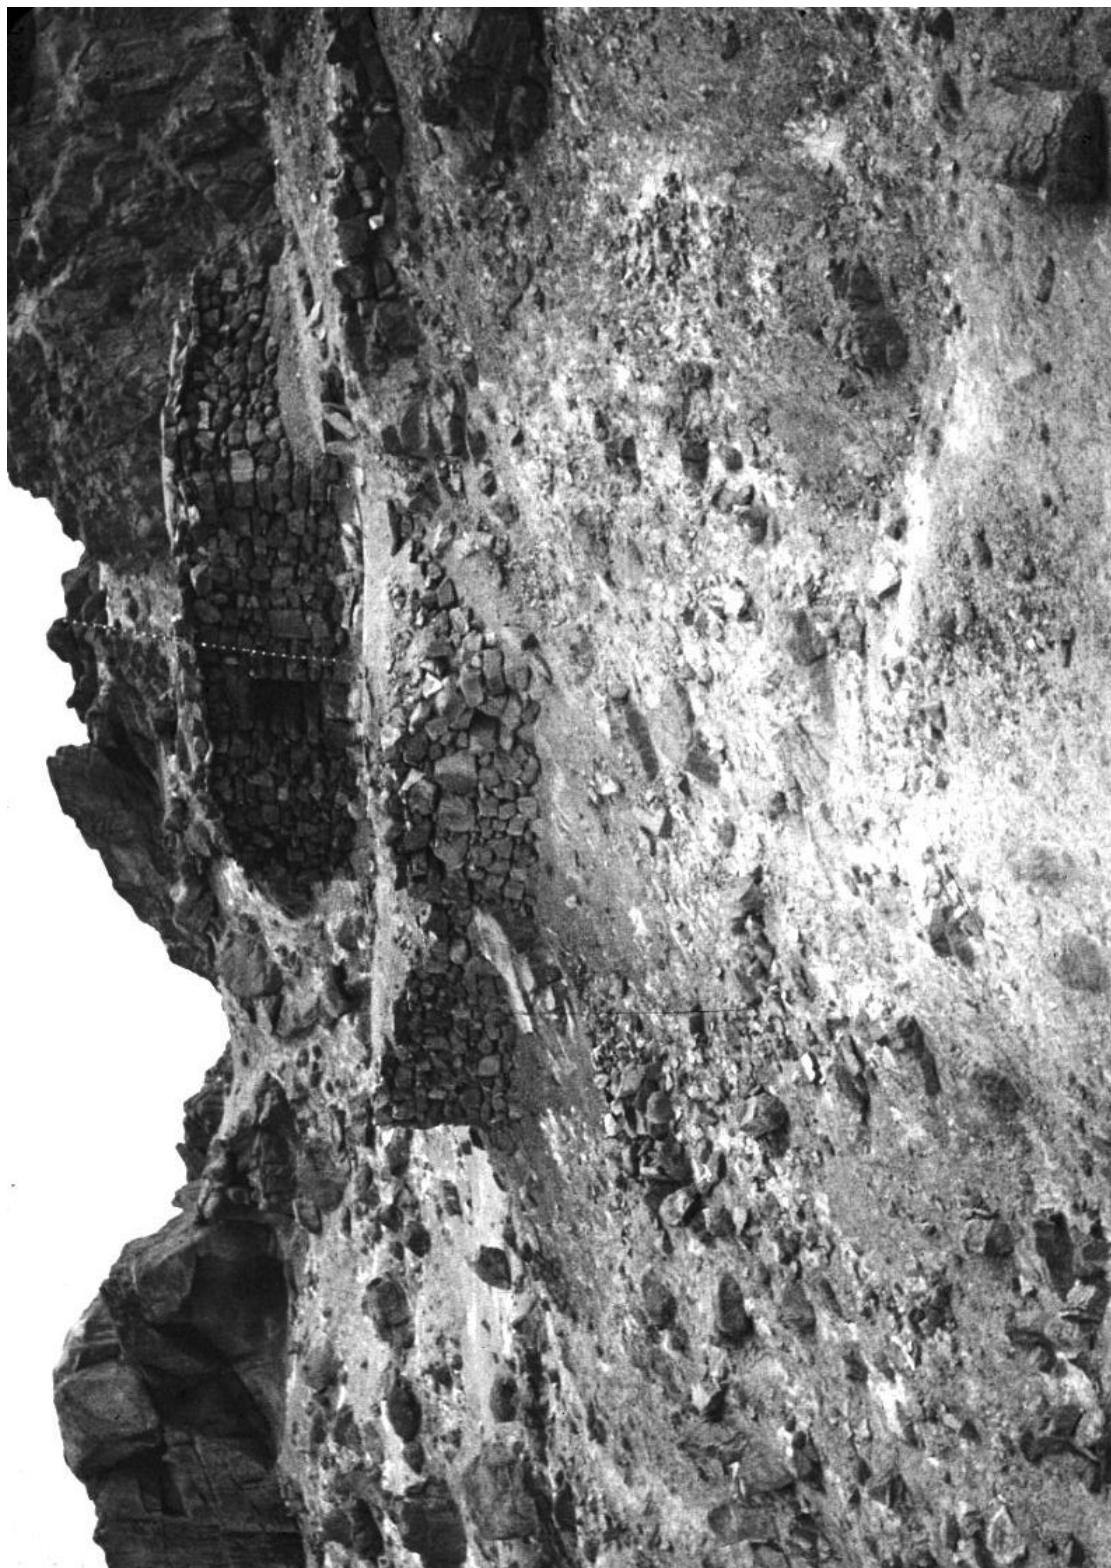
Figure 14. Another view of Tomb 1 (Burial House 1) at Quebrada de la Vacca West (photograph by F. A. Riddell, 1954. Courtesy of the California Institute for Peruvian Studies).

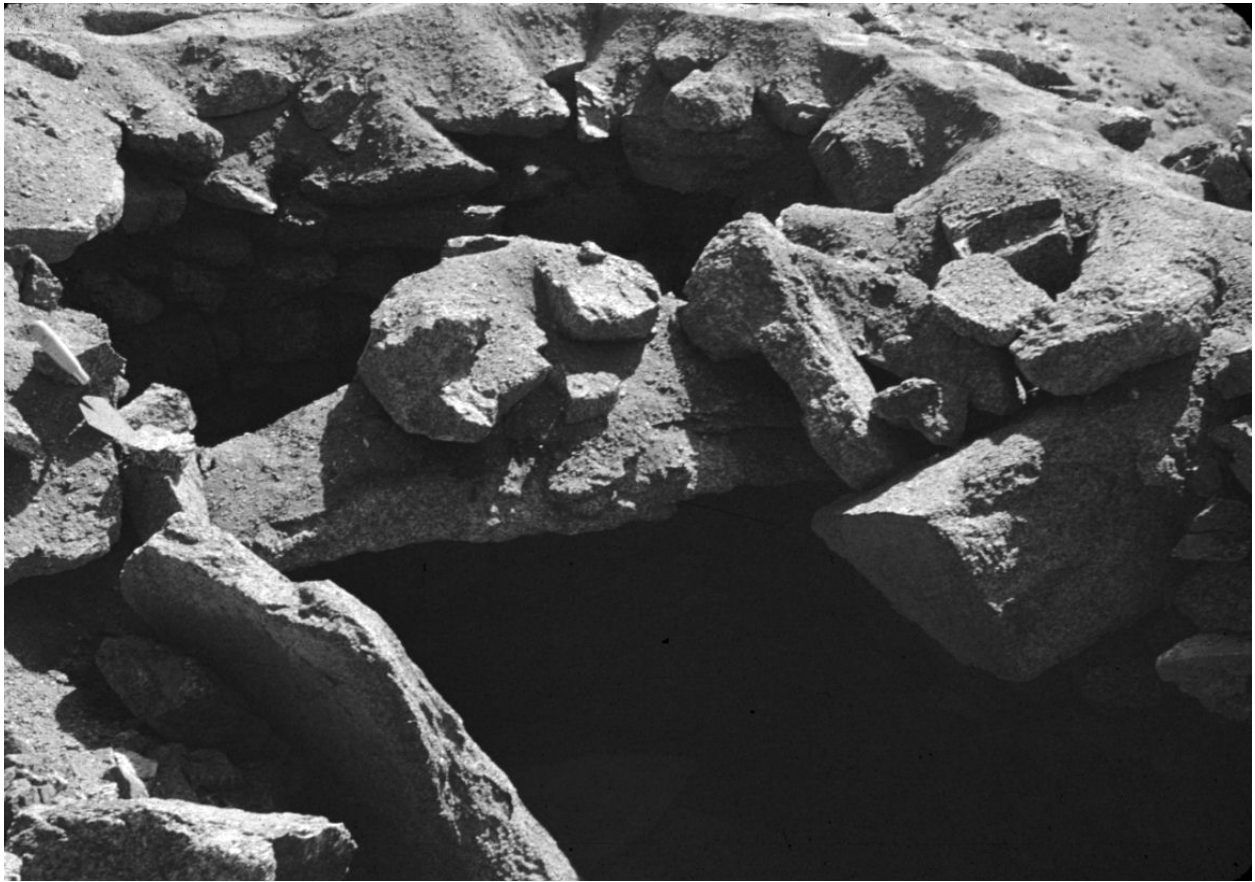
Figure 15 Tomb 1 (Burial House 1), Quebrada de la Vaca West. A few of the roof's stone lintels were still in position in 1954. See Figure 13 (photograph by F. A. Riddell, 1954, courtesy of the California Institute for Peruvian Studies).

Tomb 1 (Figures 14-16) was the best preserved of the three large tombs. It was built of a poor quality granite. It appears to have contained fewer individuals and grave goods than the others and was, therefore, treated more gently by looters. Robbery took place mainly through the roof. The central part of the roof caved in, leaving its stone beams on the floor inside.

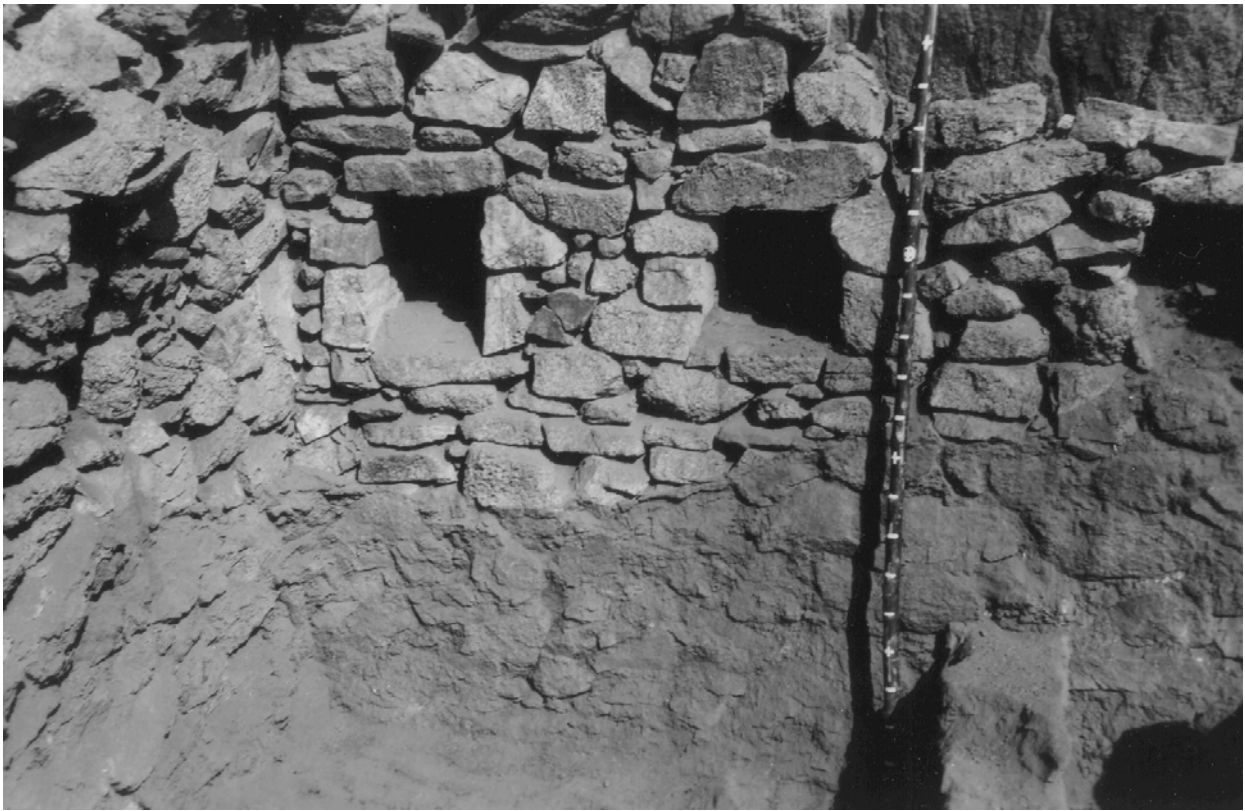
Figure 18. Interior of Tomb 2 (Burial House 2) after excavation. Note fill line on walls (photograph by F. A. Riddell, 1954, courtesy of the California Institute for Peruvian Studies).

We selected Tomb 2 (Figures 17, 18) to excavate. It was also built of granite and still in very good condition, even though it had probably been looted by the Spanish when they first came to the region. All the mummy bundles of Tomb 2, except those of infants, had been ripped open and all valuables had been removed by looters. However, during the course of the slow disintegration of the tomb, fine silt, soil, and sand from the roof sifted onto the mummy bundles before the heavy stone beams fell on top of the remains. I began excavation by removing the numerous fallen roof and wall stones and the 15 to 30cm layer of silt, soil, and sand. At this point I came upon masses of textiles. Protected by the silt, soil, and sand layer, the bones were in an excellent state of preservation, and not one skull was broken by the collapsed roof stones.

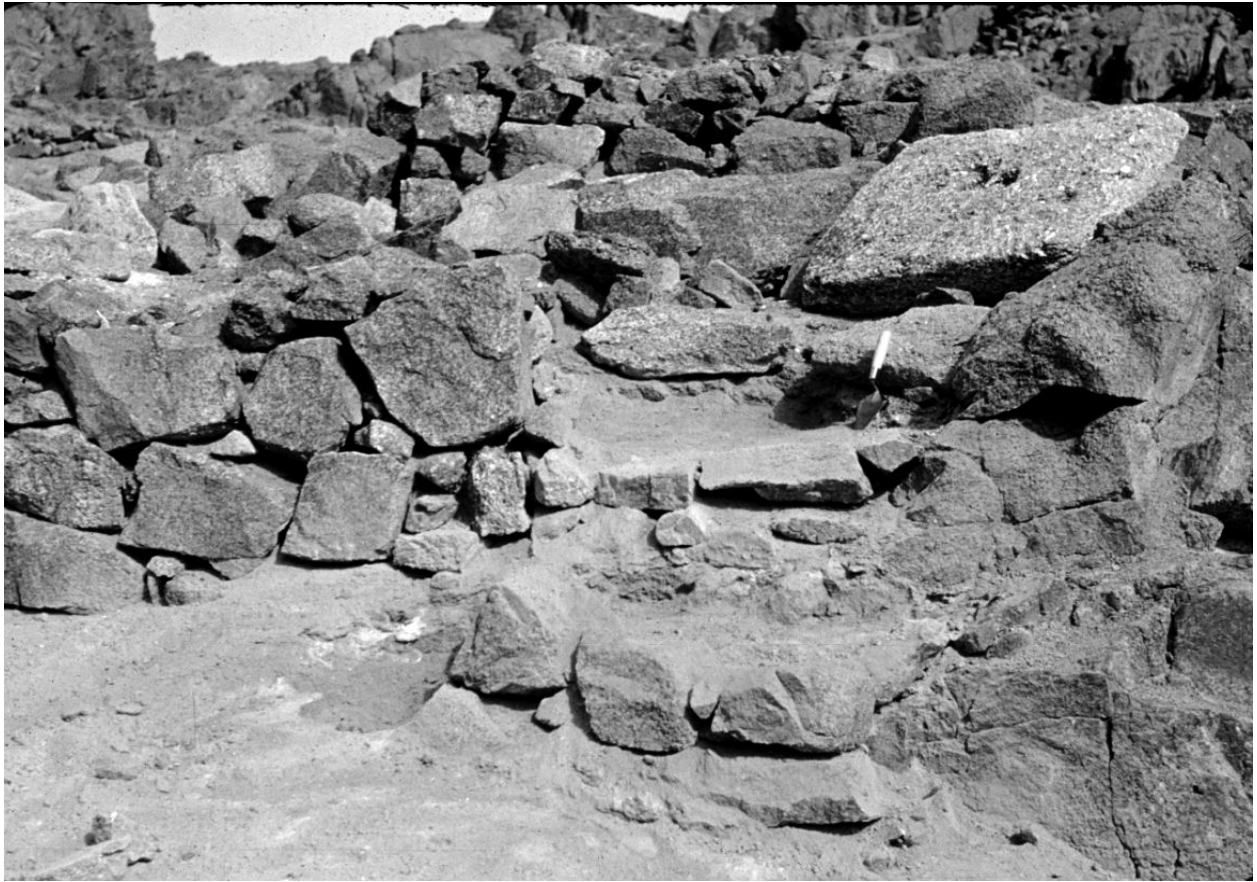
Figure 19. Stairway, Tomb 3 (Burial House 3), Quebrada de la Vaca West (photograph by F. A. Riddell, 1954, courtesy of the California Institute for Peruvian Studies).

Tomb 3 also faces directly east. It had been so badly vandalized that only its base remained. Its stones had been thrown over the side of its platform and downhill. The outline of its wall bases and the platform upon which it was built is still visible, so we could determine its approximate size and orientation. It was of about the same size as the other two large platform tombs. Three steps led up to the platform (Figure 19). Its roof beams are approximately 1.5m long. Its limestone blocks had the following dimensions:

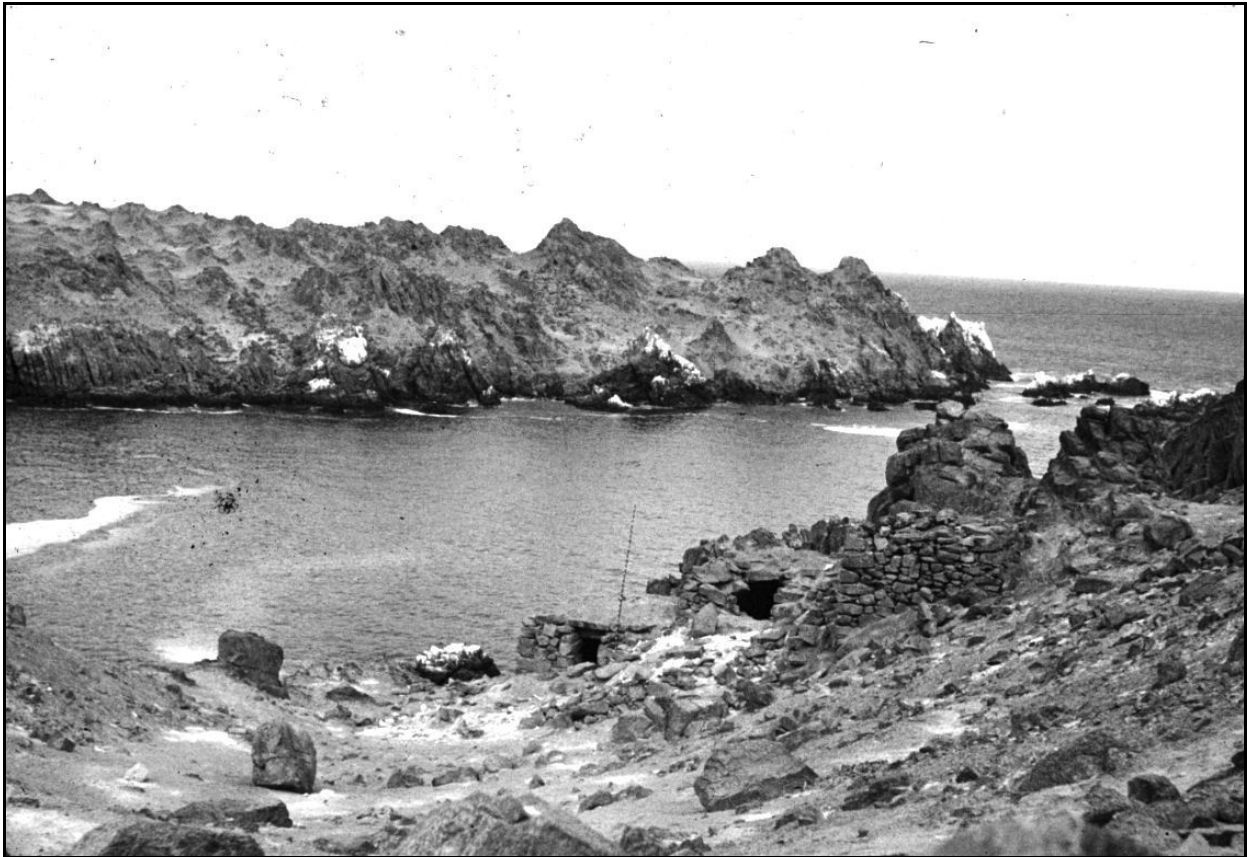
Figure 20. Small burial houses at Quebrada de la Vaca West (photograph by F. A. Riddell, 1954, courtesy of the California Institute for Peruvian Studies).

To the right, below and quite close to Tomb 1 are the remains of burial chambers no more than half the size of the large tombs (Figure 20). There were no internal niches or supporting platforms with stairs. The topmost *chullpa* faces east and has an entrance in one of its broad sides, but the lower two face north and have entrances in their narrow sides. Only one has its entrance preserved in its entirety. It has a double lintel with a recess. That is, the inner, lower beam rests partly on stones of the corbelled wall of its sides, and partly on the entrance stones. The front and higher lintel roofs the entrance proper. This gives a neat, decorative effect. An entrance platform, a small, stone-paved apron, is directly in front of the entrance.

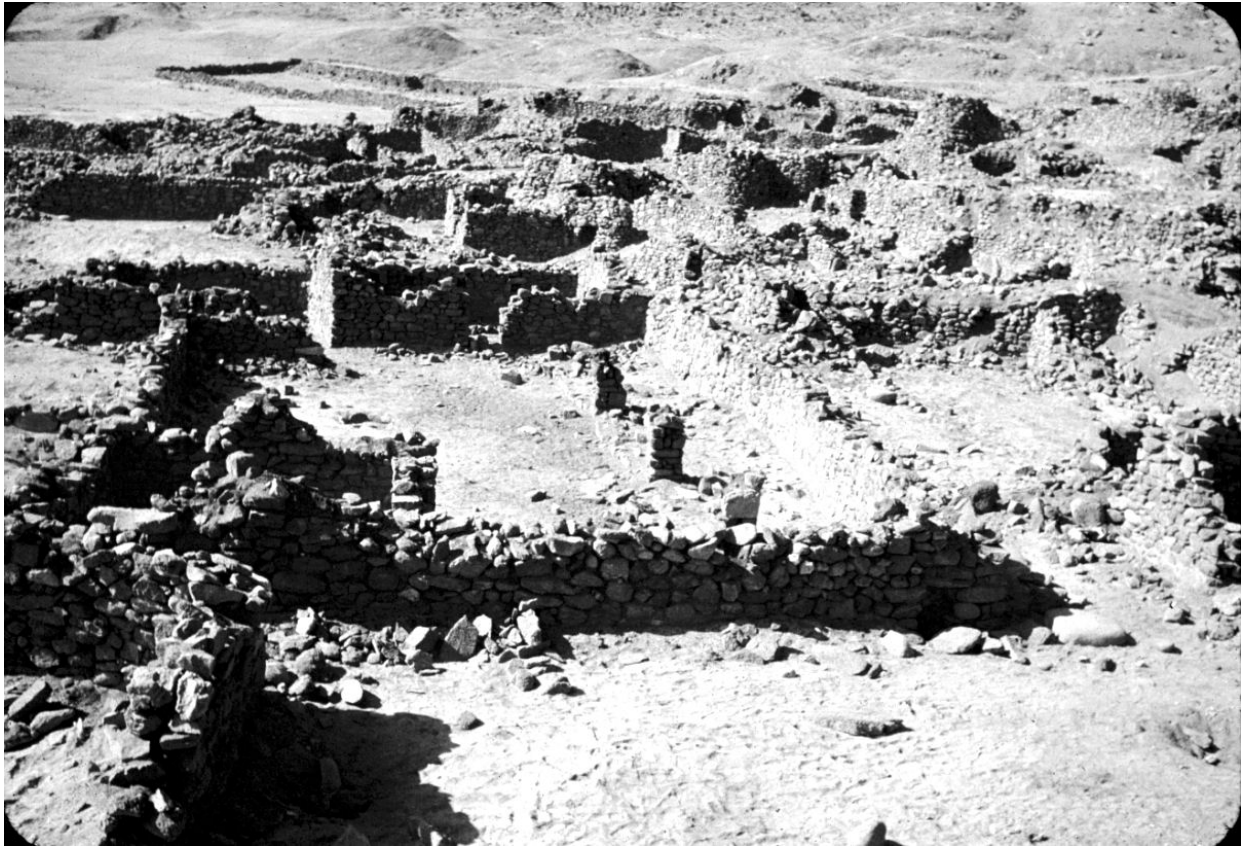
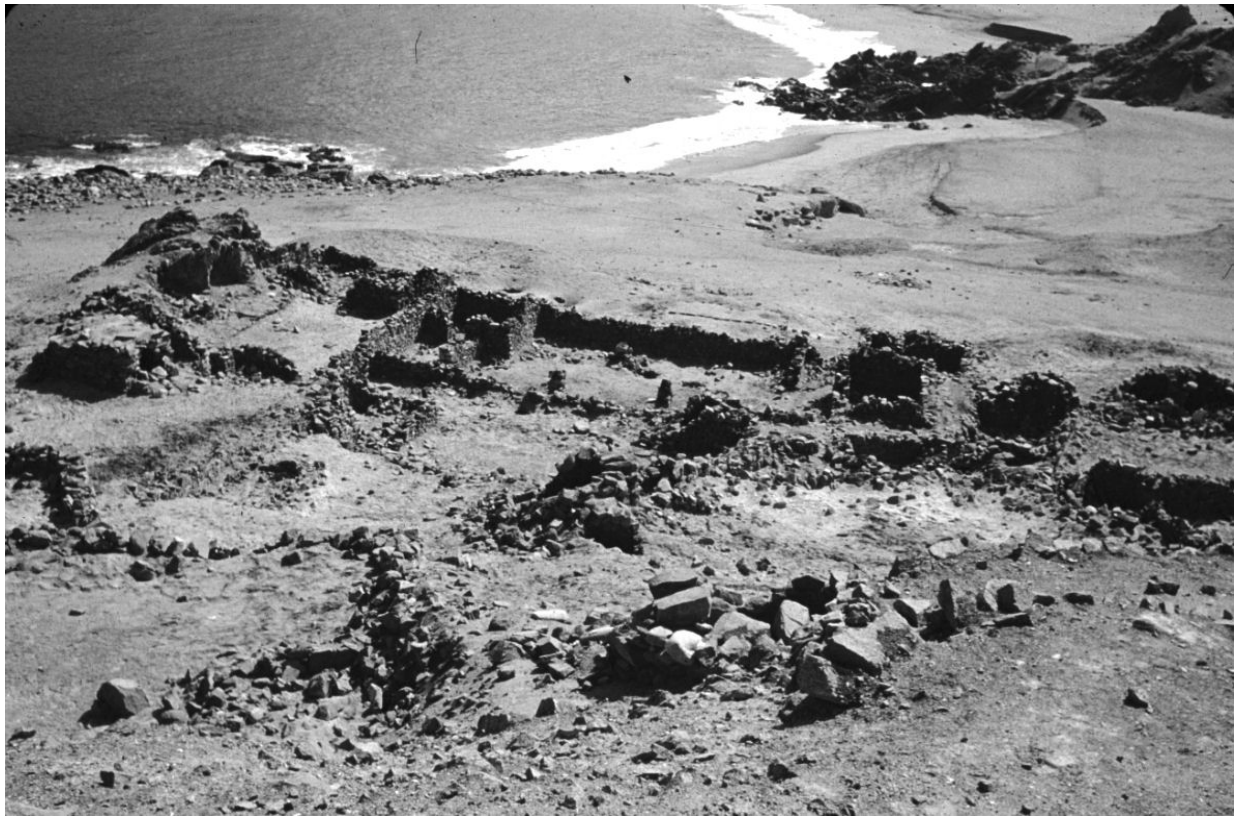
Figure 21. Compound 1 (foreground), Quebrada de la Vaca (photograph by F. A. Riddell, 1954, courtesy of the California Institute for Peruvian Studies).

Figure 22. Compound 1, Quebrada de la Vaca (photograph by F. A. Riddell, 1954, courtesy of the California Institute for Peruvian Studies).

Compound 1 (Figures 21, 22):
