Effects of Frost Heave on a Soil Nail Wall in Brunswick, Maine

**EFFECTS OF FROST HEAVE ON A SOIL NAIL WALL
IN BRUNSWICK, MAINE**

A THESIS

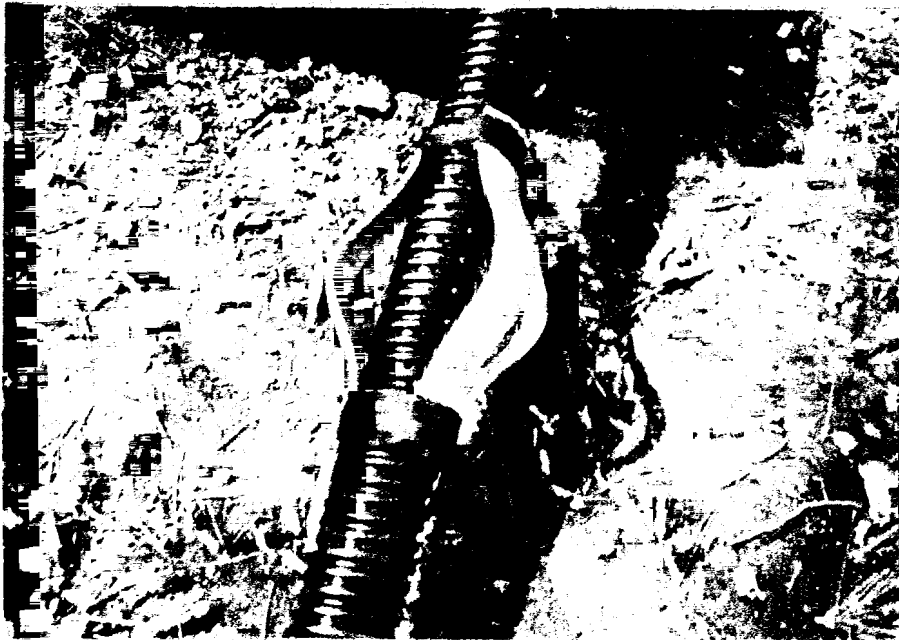
Figure 3-13: Detail showing stabilizer applied to HDPE sheathing

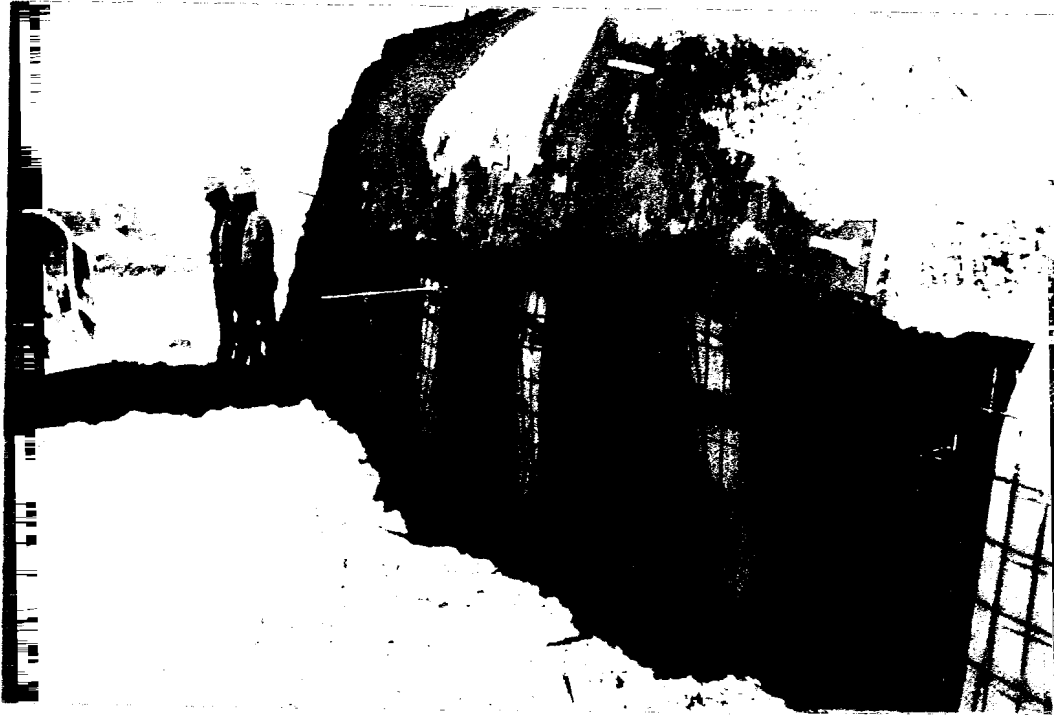
Figure 3-16: First row of nails completed, second bench excavated. Note finished shotcrete, bearing plates and end nuts on nails, vertical drainage strips, and reinforcement for shotcreting of second bench.

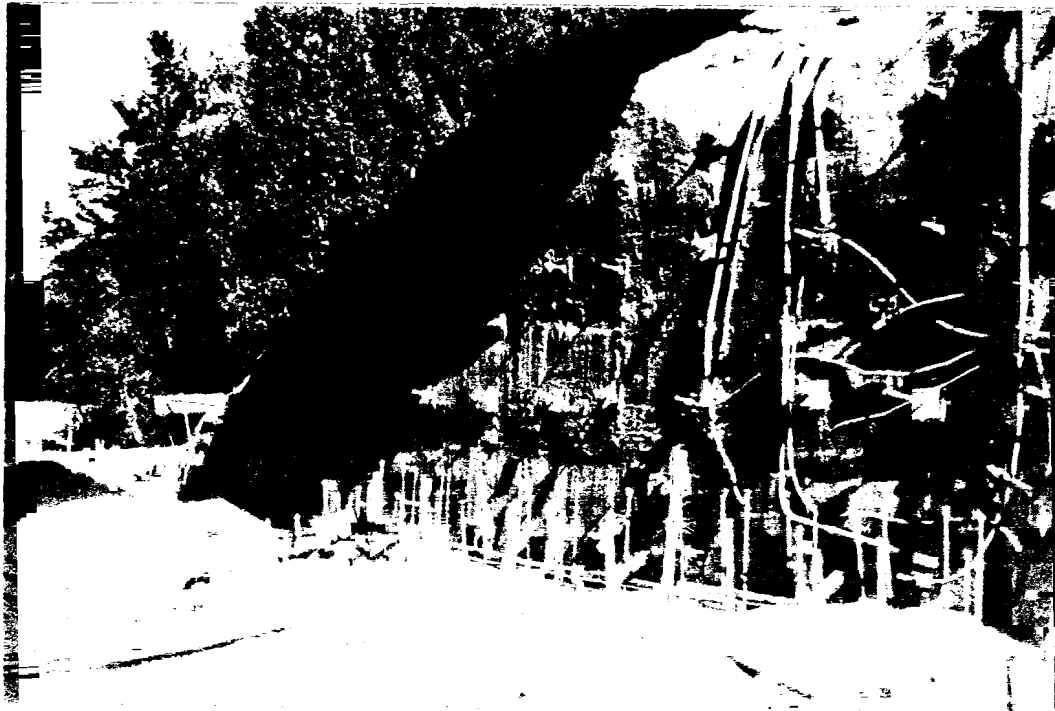
Figure 3-17: Nail installation complete. Note instrumented nails and conduit for instrument wires to top of wall. Formwork for footing of concrete facing wall is in progress.

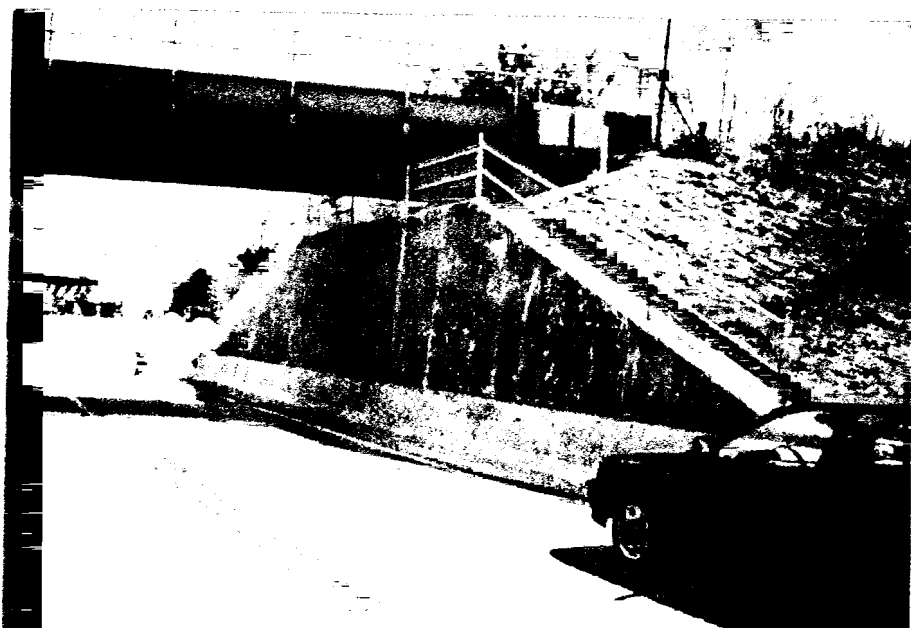
Figure 3-19: Completed concrete facing wall, rain gutters, and traffic barrier. Note gray rectangular instrument boxes attached to railroad bridge at top center.

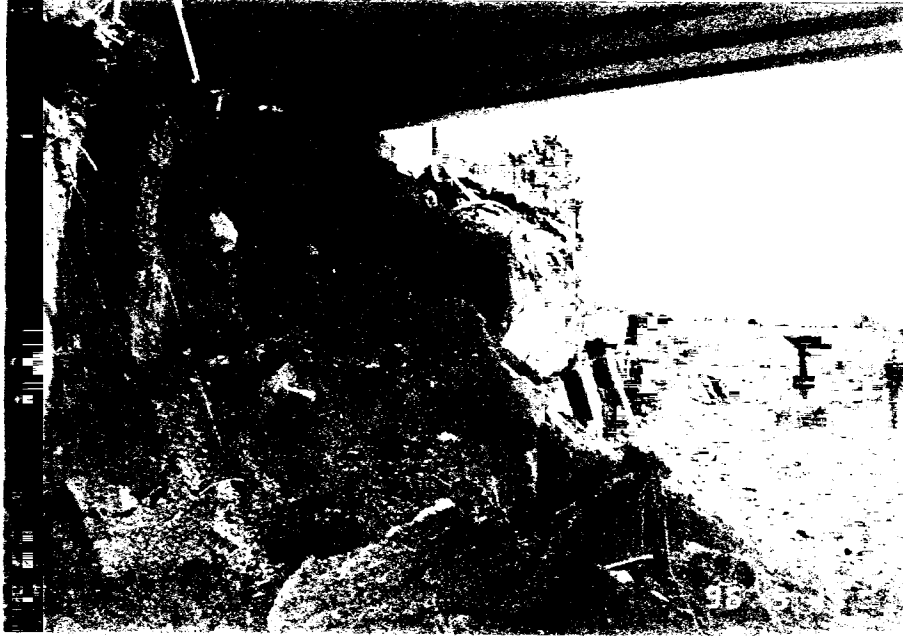
Figure 3-21: Sloughing failure on non-instrumented wall

Rainy conditions had prevailed for several days preceeding the excavation and failure, possibly contributing to a loss of apparent cohesion in the essentially granular fill.
