Summary Report of Enhanced Monitoring and Pollution Source Tracking Efforts in the Willard Beach Watershed, Maine, 2012-2016

**MAINE HEALTHY BEACHES PROGRAM
SUMMARY REPORT OF ENHANCED MONITORING AND
POLLUTION SOURCE TRACKING EFFORTS
IN THE WILLARD BEACH WATERSHED
SOUTH PORTLAND, MAINE
2012-2016**

Meagan Sims and Keri Kaczor – Maine Healthy Beaches Program
with assistance from
Fred Dillon – South Portland Stormwater Program Coordinator

July 2017

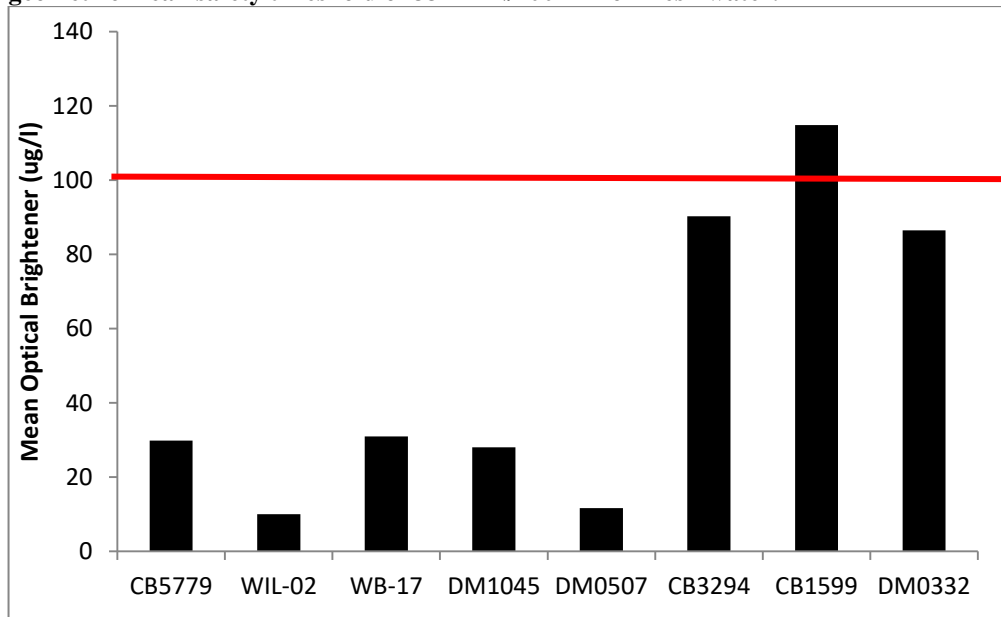
Figure 3. Mean OB (ug/L) concentrations by monitoring site in the stormwater system impacting Willard Beach from 2012-2016 (monitoring stations with 5 samples or greater included). Red solid line indicates the OB lower threshold level considered by MHB as a “red-flag” for potential human wastewater contamination (100 ug/L).

Overall, mean OB values were relatively low (less than 40 µg/l) for the majority of sites monitored (2012-2016), suggesting non-human sources (wildlife, pets) are likely the principal contributors to stormwater bacterial pollution at these locations. There is also a considerable body of research that suggests bacterial regrowth (i.e., “biofilms”) in urban stormwater systems can result in nonattainment of water quality standards. However, human sources cannot be ruled out as optical brightener concentrations varied between monitoring sites, with at least two mean site values (CB1599, DM0423) and one single sample value (DM0424) exceeding the 100 µg/l threshold (Table 1, Figures 2-3).

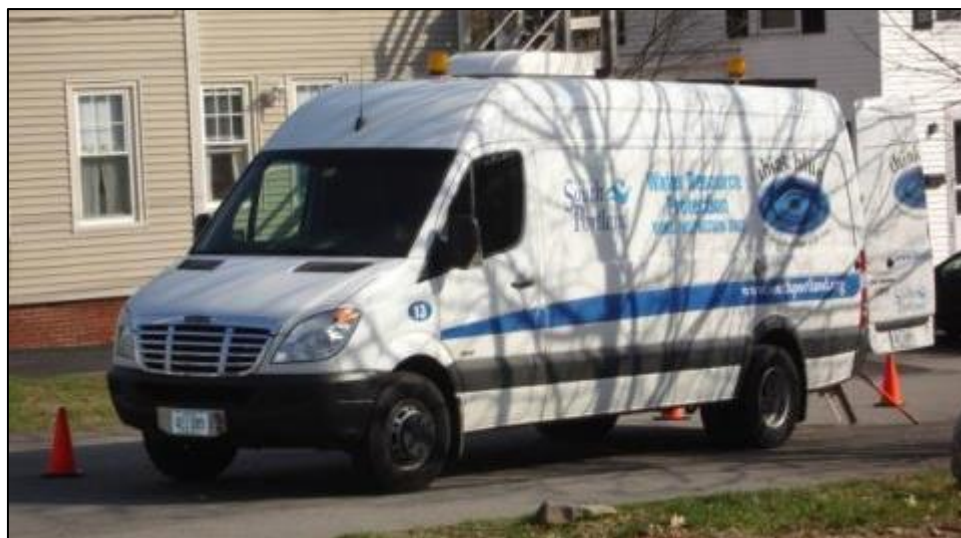
Following the August 2014 discovery of significantly elevated bacteria results in a portion of the separated stormwater system, City staff conducted closed-circuit television inspections in September 2014 to identify potential cross-connections with the public sewer (Figure A4). While no direct connections of sewer service laterals from residences into the separated stormwater system were observed, there were three instances of the public sewer main crossing directly through separated stormwater structures. Subsequent dye testing by City staff identified and eliminated an illicit cross connection between the sewer and stormwater infrastructure at site DM0294 (Figure A5).

Figure A3. City of South Portland’s closed-circuit television inspection van assessing the condition of the sewer and stormwater systems in the Willard Beach Watershed.

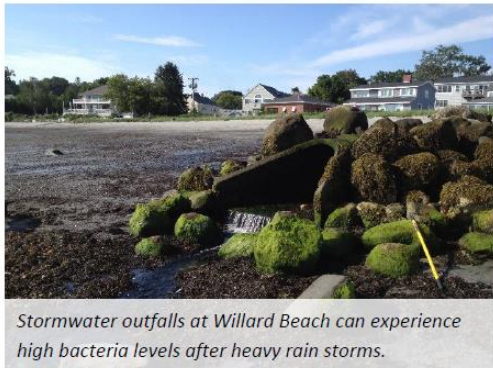
Stormwater outfalls at Willard Beach can experience high bacteria levels after heavy rain storms.
