APPENDIX A – EXISTING ACCESS MANAGEMENT **FIGURES**

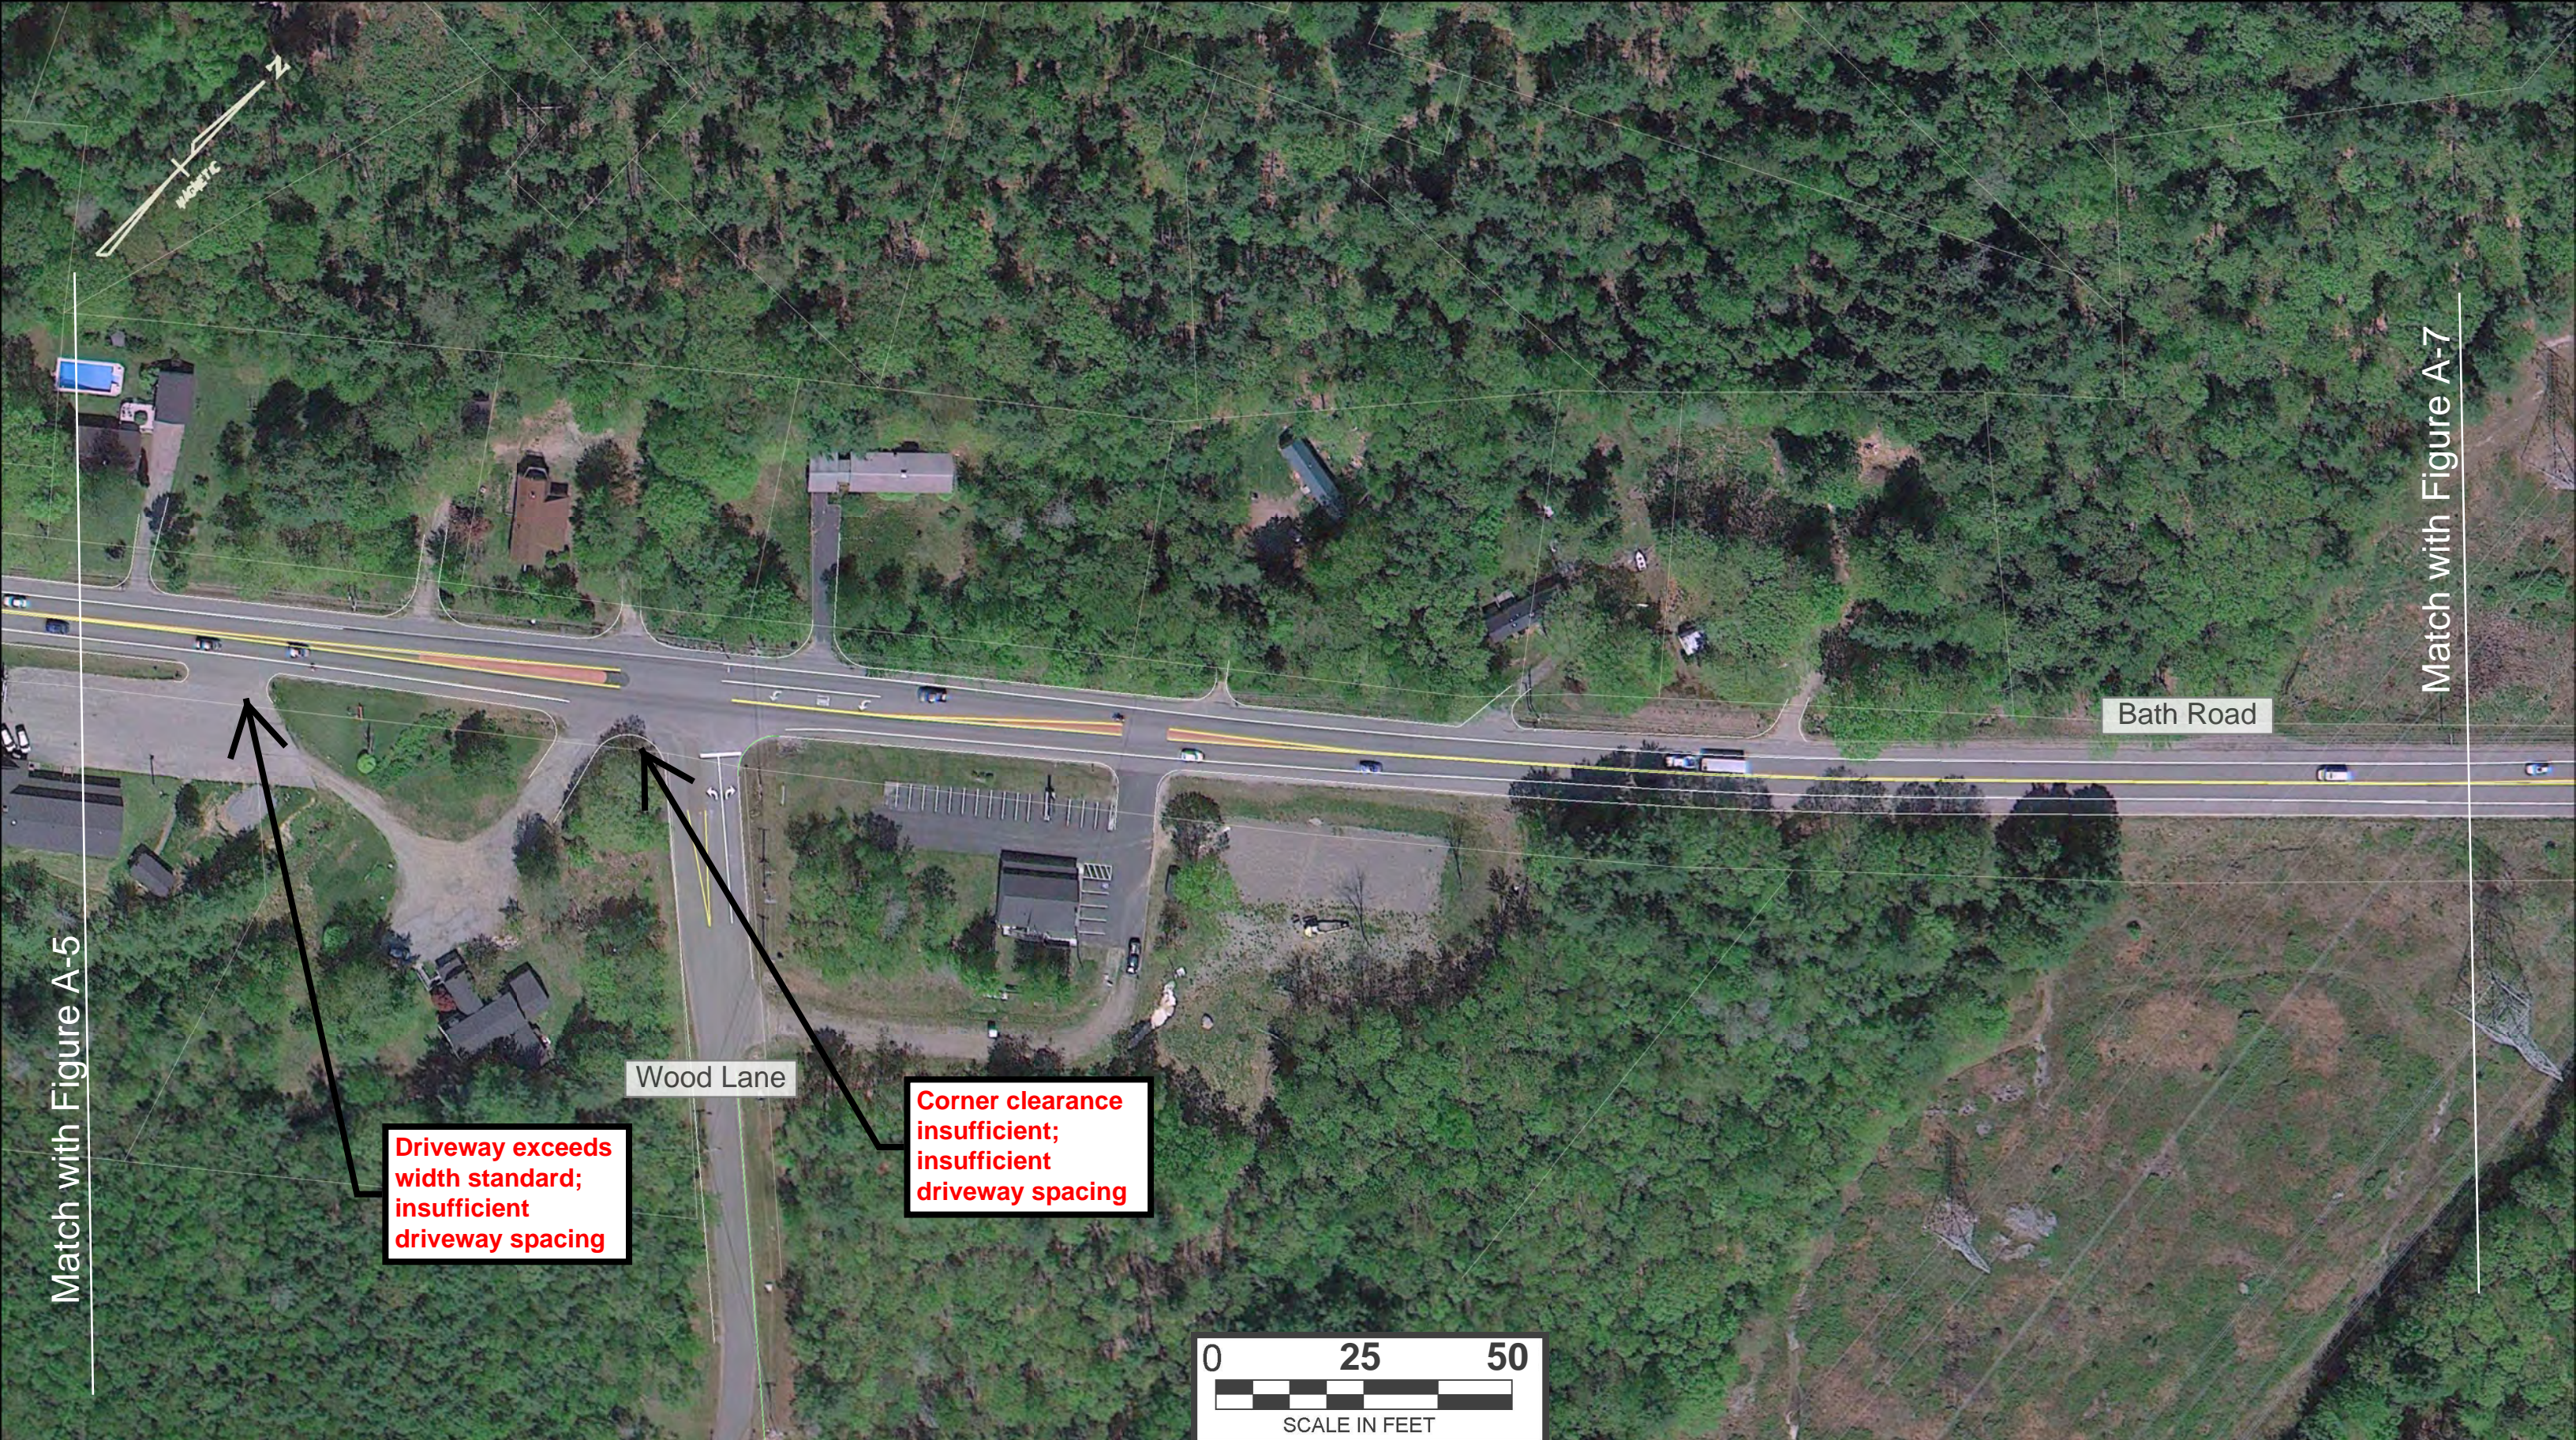
Match with Figure A-5

Driveway exceeds width standard; insufficient driveway spacing

Corner clearance insufficient; insufficient driveway spacing
